## Appendix 12.3

### Site Visit Photographs

## Appendix A-Site Visit Photos

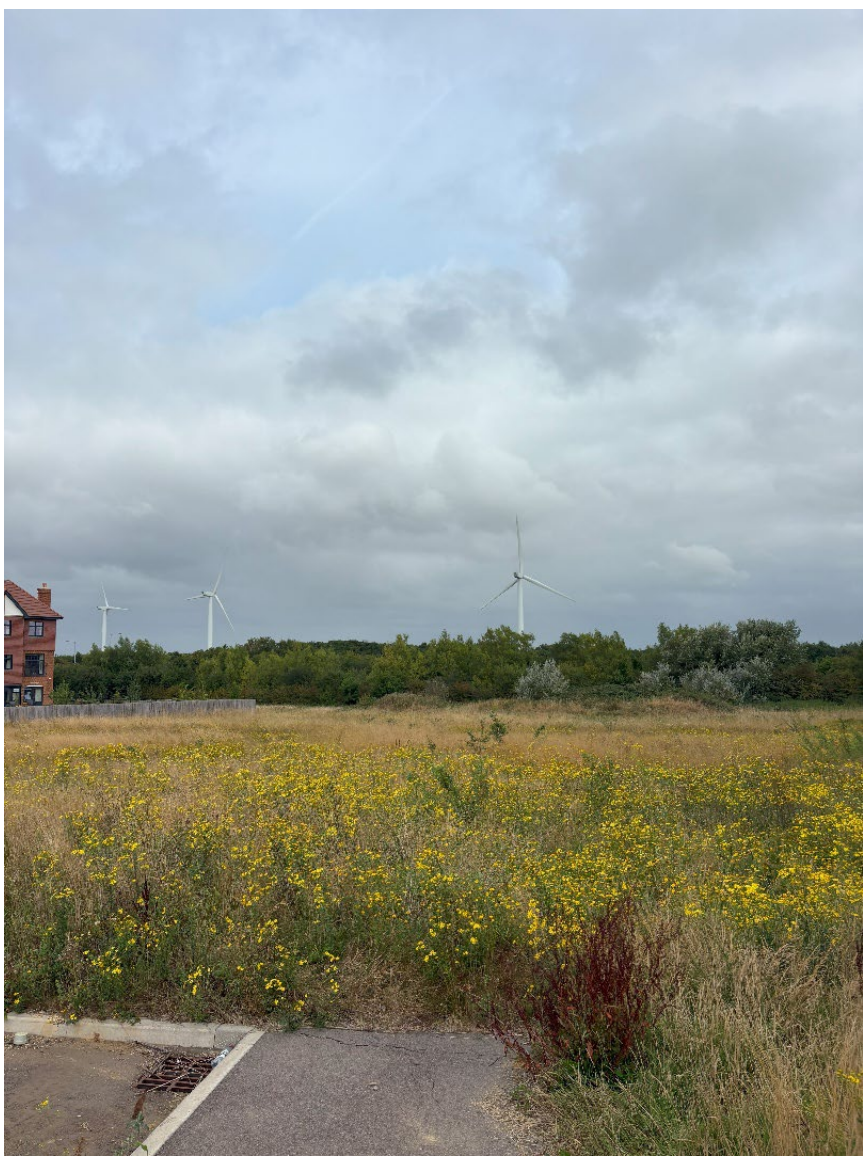
| Description | Photo |
|---|---|
| Entry to the site and overall topography | A photograph showing the entry to a site. In the foreground, there is a paved area with a metal grate. To the right of the grate is a large bush with reddish-brown leaves. The middle ground is filled with tall, yellow wildflowers. In the background, there is a line of green trees, and behind them, several white wind turbines are visible against a cloudy sky. A small red brick building is partially visible on the left side of the image. |

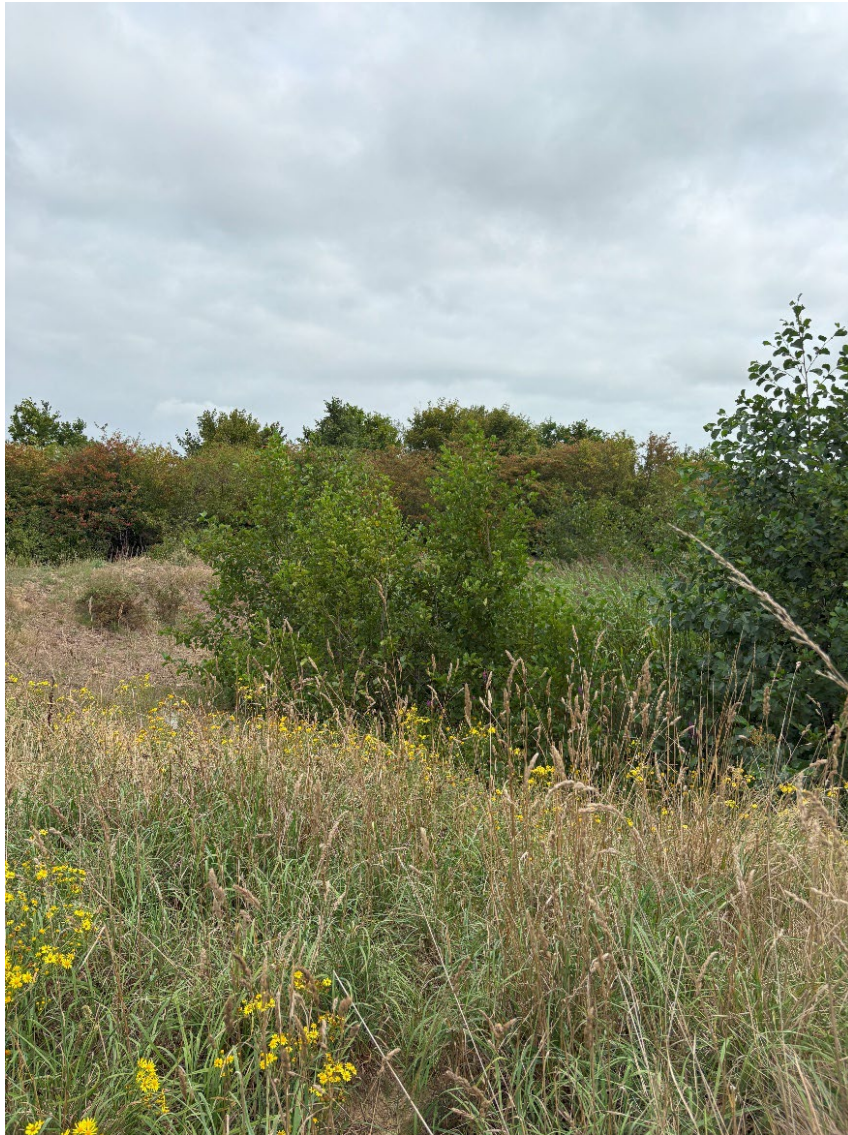
'Pond' feature in northeast corner. Raised banks out of ground. Vegetation identified within the feature indicates water present at times

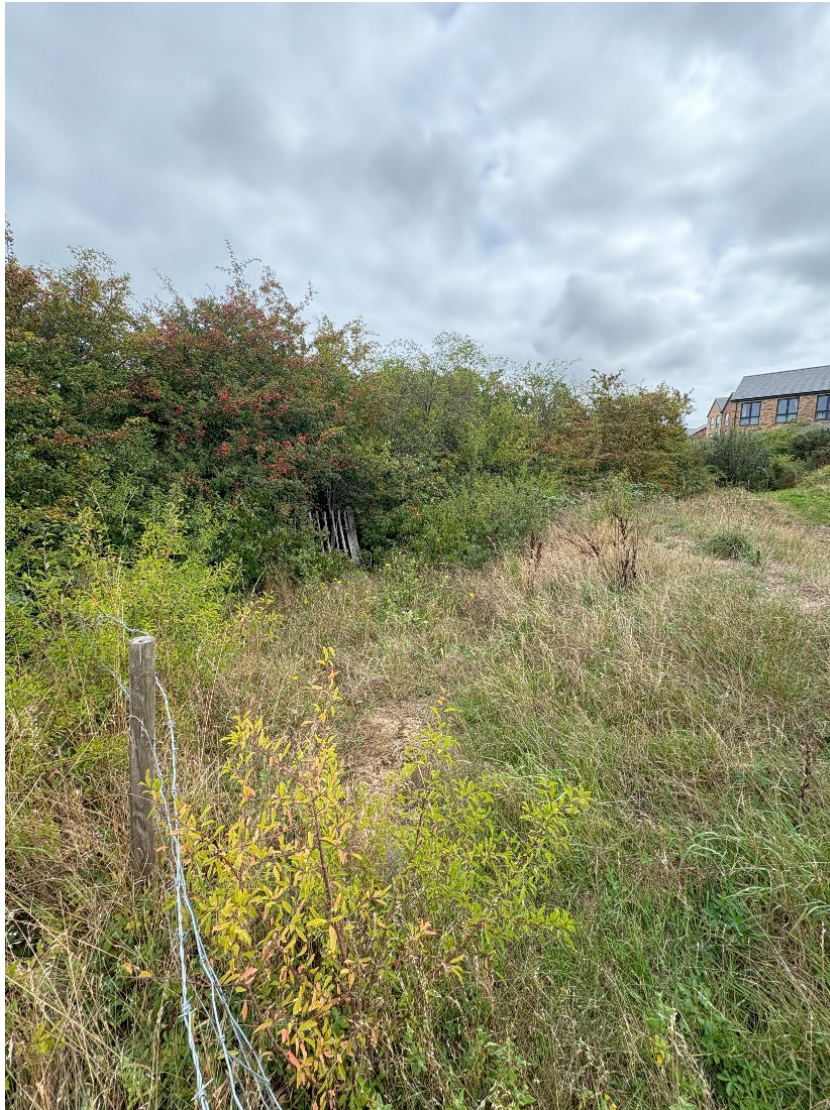
Culvert  
location on  
OS  
MasterMap.  
Could not  
get closer  
due to  
barbed wire

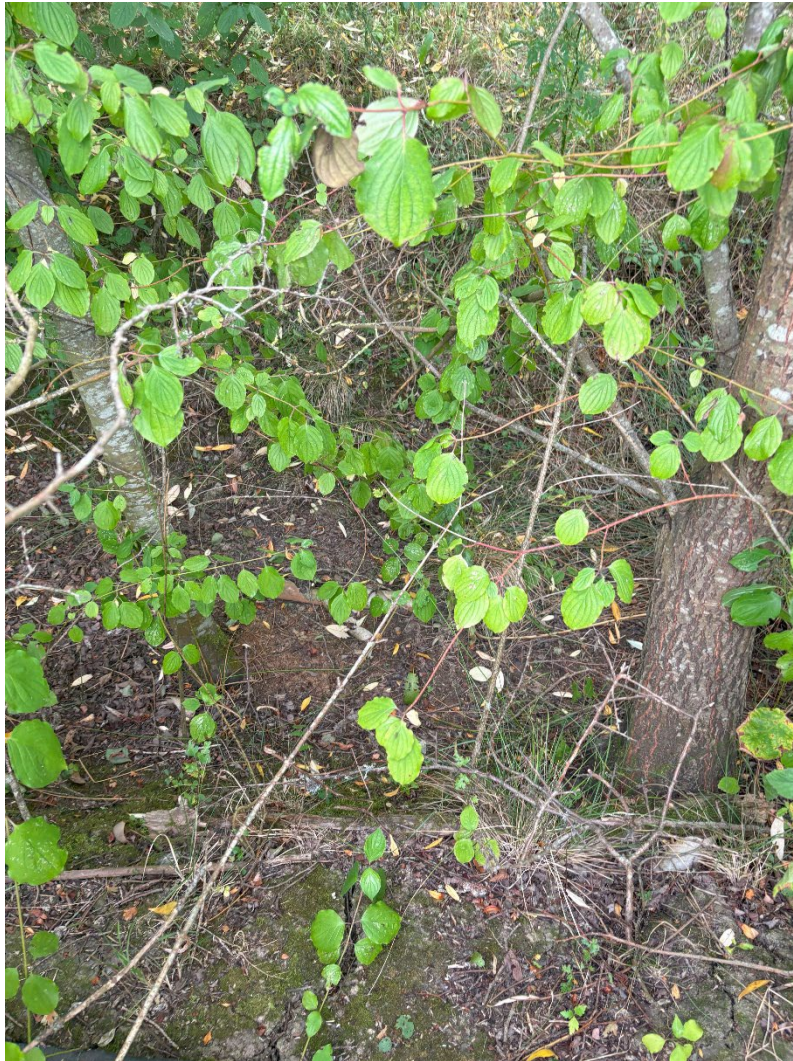
Ditch seen along boundary. Approximately 1m wide and 0.5m deep. Dry at time of visit. Unclear in image.

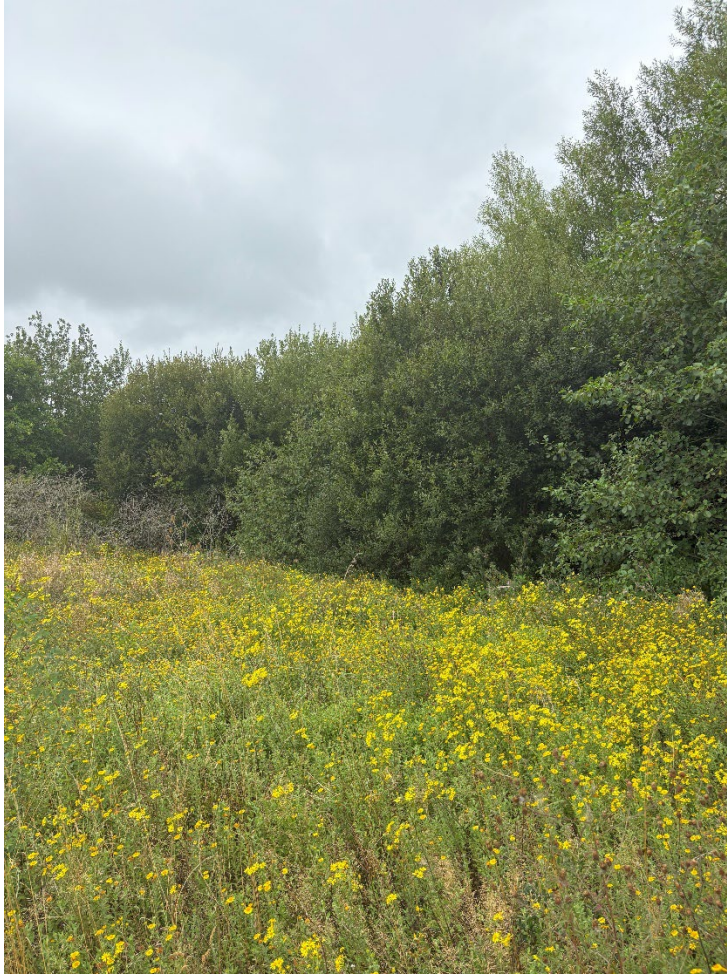
West area  
of site.  
Inaccessibl  
e

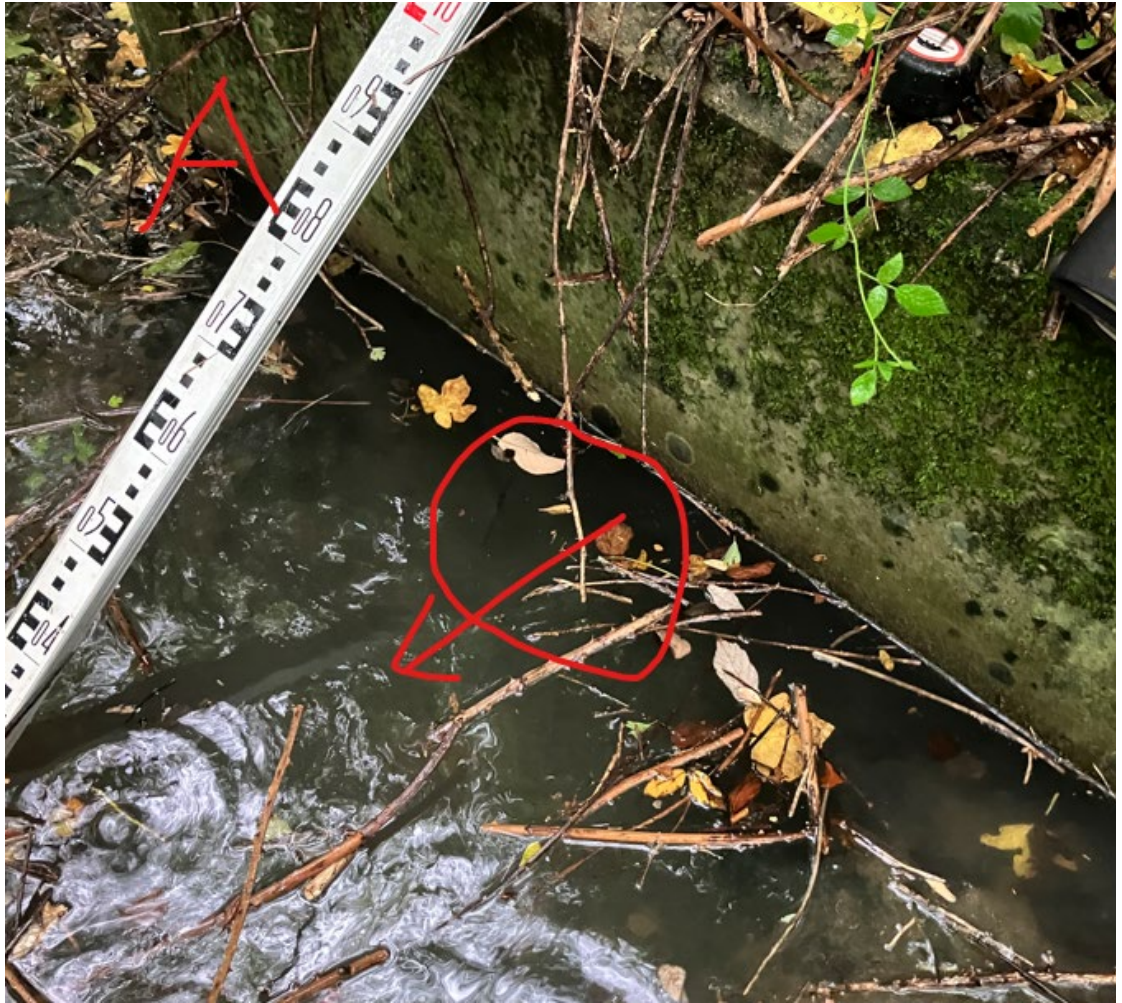
Culvert at  
northwest  
corner of  
site –  
estimated  
to measure  
200mm  
diameter

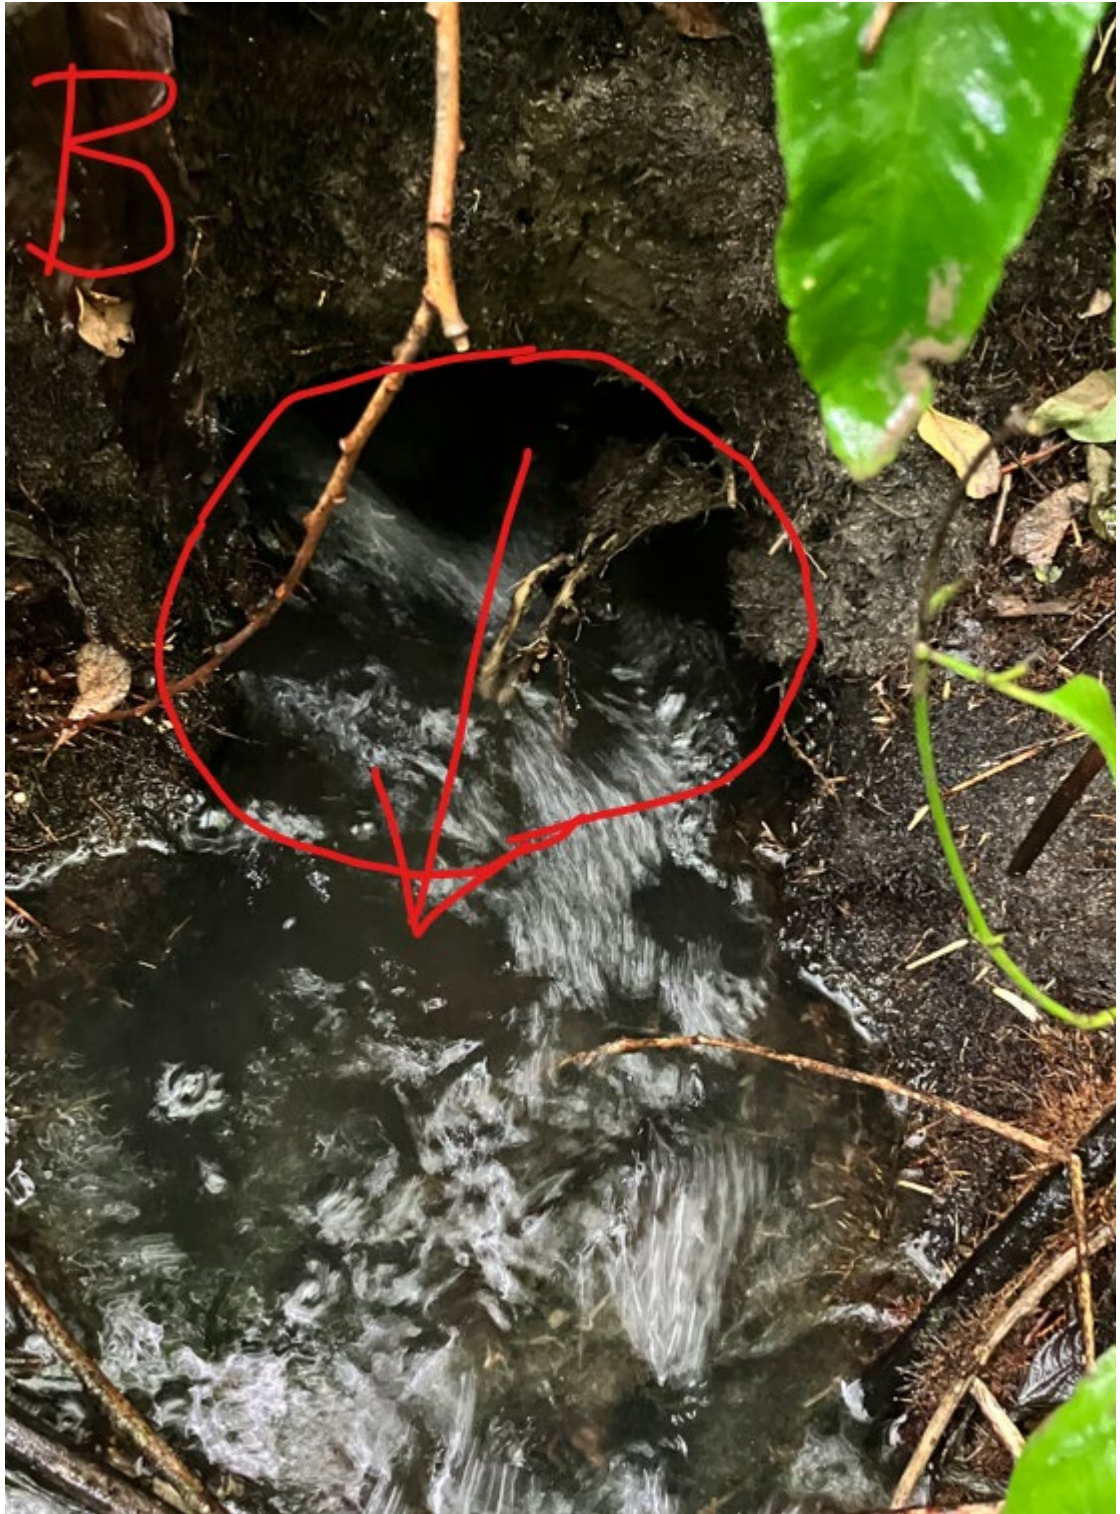
Culvert/outfall to the northeast of the site. Estimated as 200mm diameter
