# Crest Nicholson

## Land North East of Harpenden Between Lower Luton Road, Bower Heath Lane and Common Lane

### Preliminary Geotechnical Report

794-DES-CAS-31270  
Geotechnical Report  
06  
04 March 2026

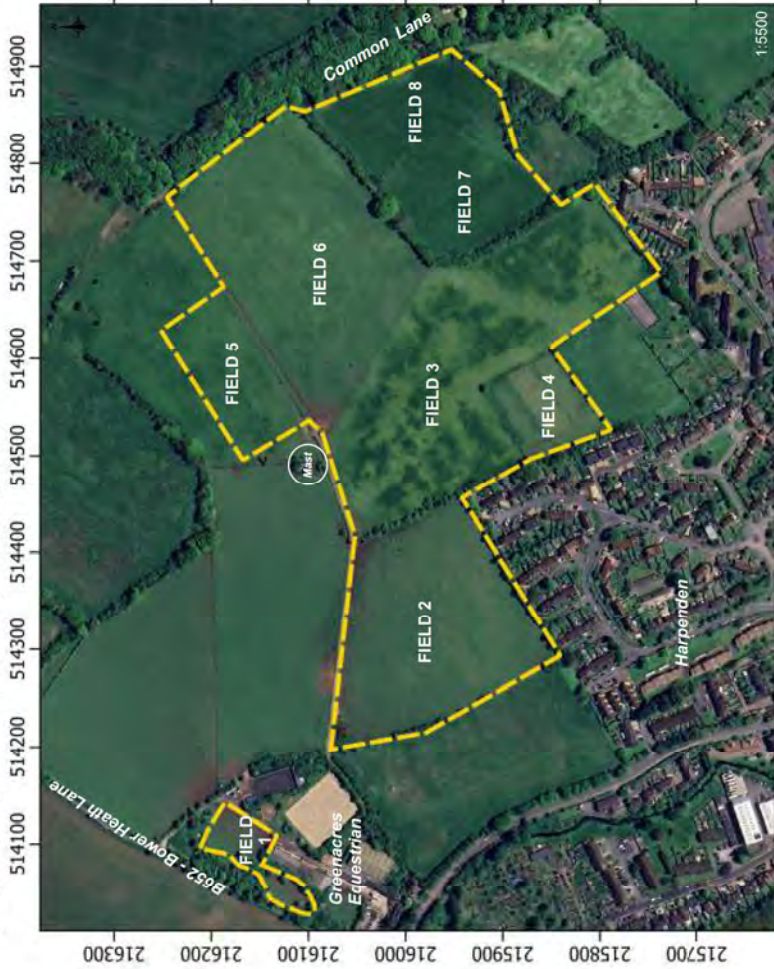
B - LiDAR IMAGERY (Defra, 1m resolution, 2015, with ERT survey profile locations)

Publicly available Lidar imagery (Defra, 2015) indicates a few anomalous zones (e.g. depressions) spread across the site, which have been highlighted in Figure 1B.

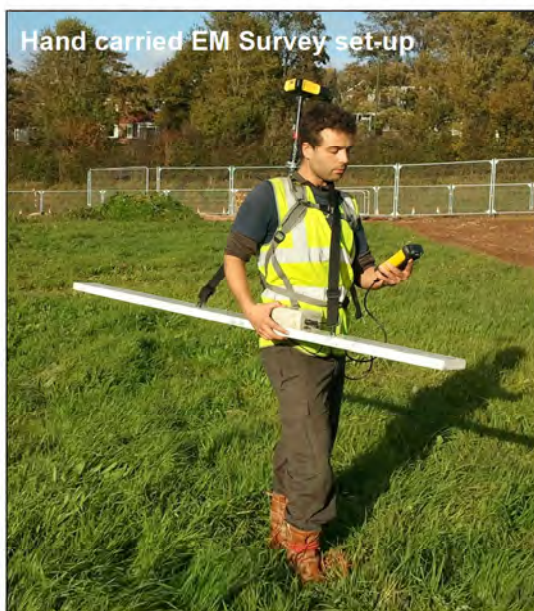
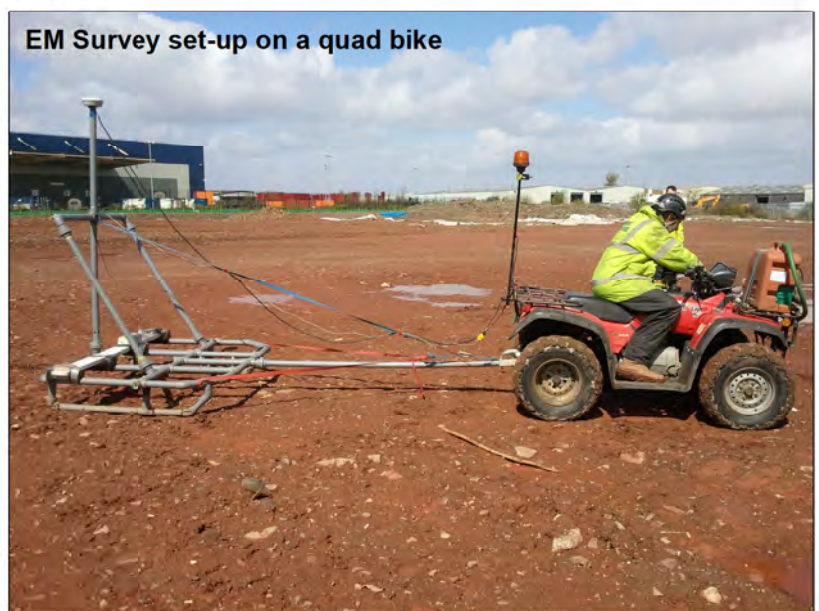
## General principle of EM surveying

Electromagnetic (EM) surveys are carried out using man-portable instruments with readings taken on a regular grid or along selected traverse lines. If site conditions permit, the EM instrument may be mounted/towed behind a quad bike and positional control is provided by dGPS. The selection of the particular EM instrument (GEM2/EM-38/EM-31/EM-34) is based on the required penetration depth of the survey.

The results from the EM survey can be presented as colour contoured plots of conductivity and inphase (metal response) data. In general terms, a relative increase in conductivity values usually indicates a local increase in clay content or water saturation. However, if there is a corresponding increase in the inphase response, the influence of some artificial source is likely (i.e. metal).
