PROJECT TITLE  
LAND AT REDBOURNE ROAD  
HEMEL HEMPSTEAD, HP2

DRAWING DETAIL  
UTILITIES AND DRAINAGE SURVEY.  
SHEET 31 OF 31

### **Land Adjacent to Holtsmere End Lane (South)**

This report presents the findings of a Ground Investigation undertaken to initially assess the infiltration and drainage characteristics of the soils throughout the area. Pertinent findings and conclusions may be summarised as follows:

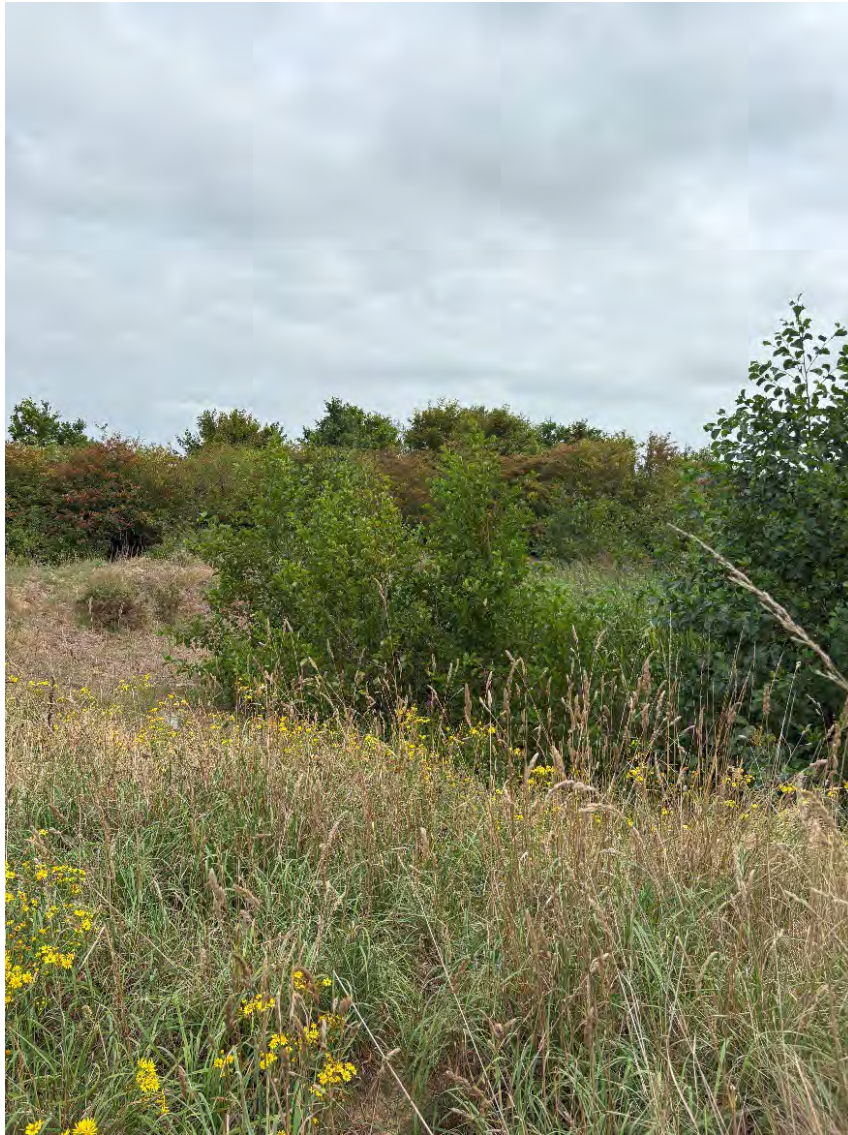
'Pond' feature in northeast corner. Raised banks out of ground. Vegetation identified within the feature indicates water present at times

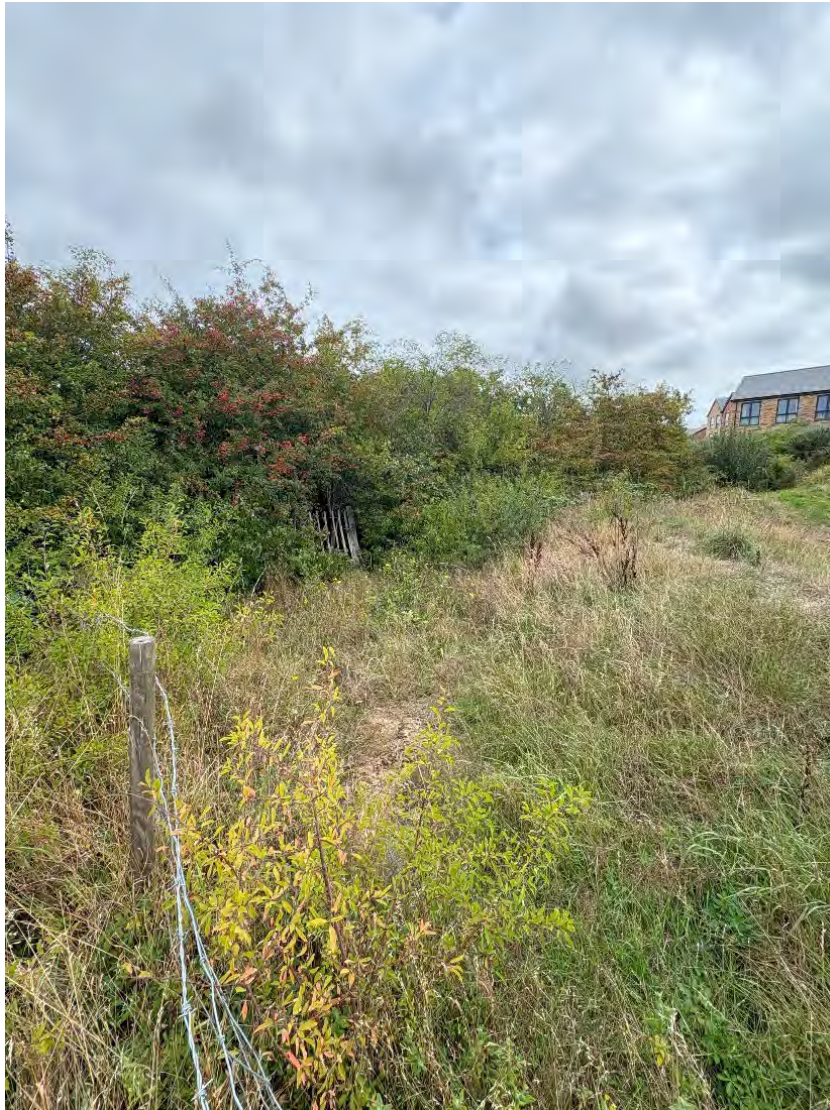
Culvert  
location on  
OS  
MasterMap.  
Could not  
get closer  
due to  
barbed wire

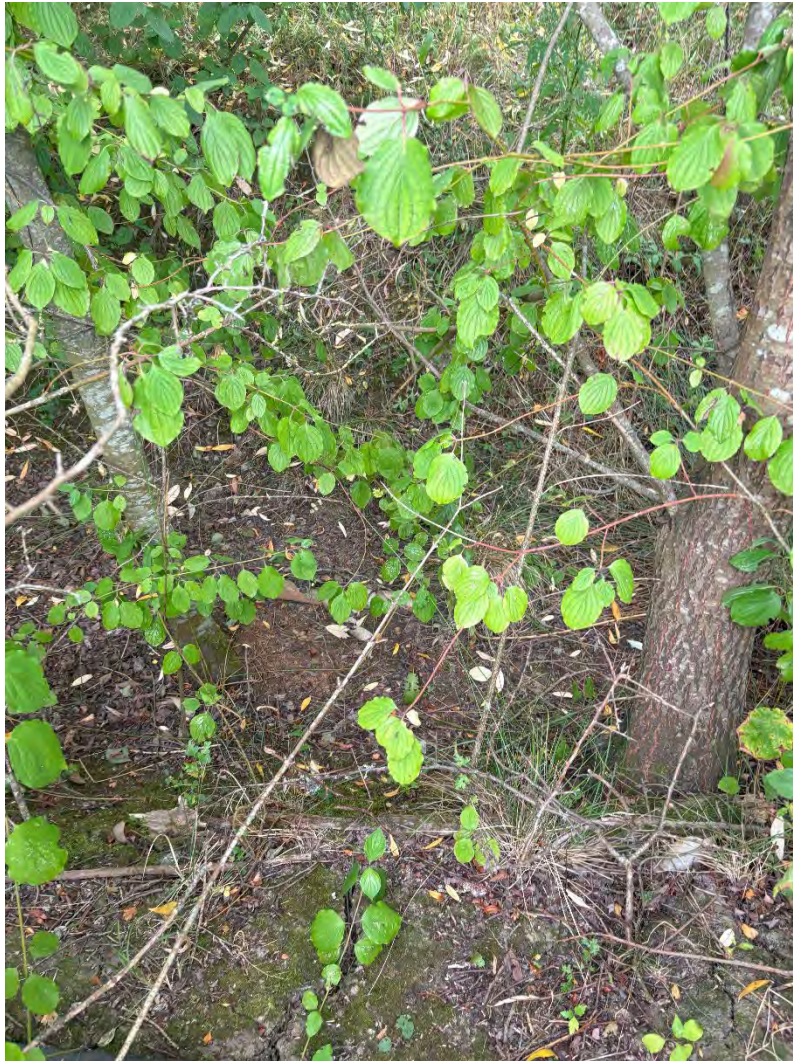
Ditch seen along boundary. Approximately 1m wide and 0.5m deep. Dry at time of visit. Unclear in image.

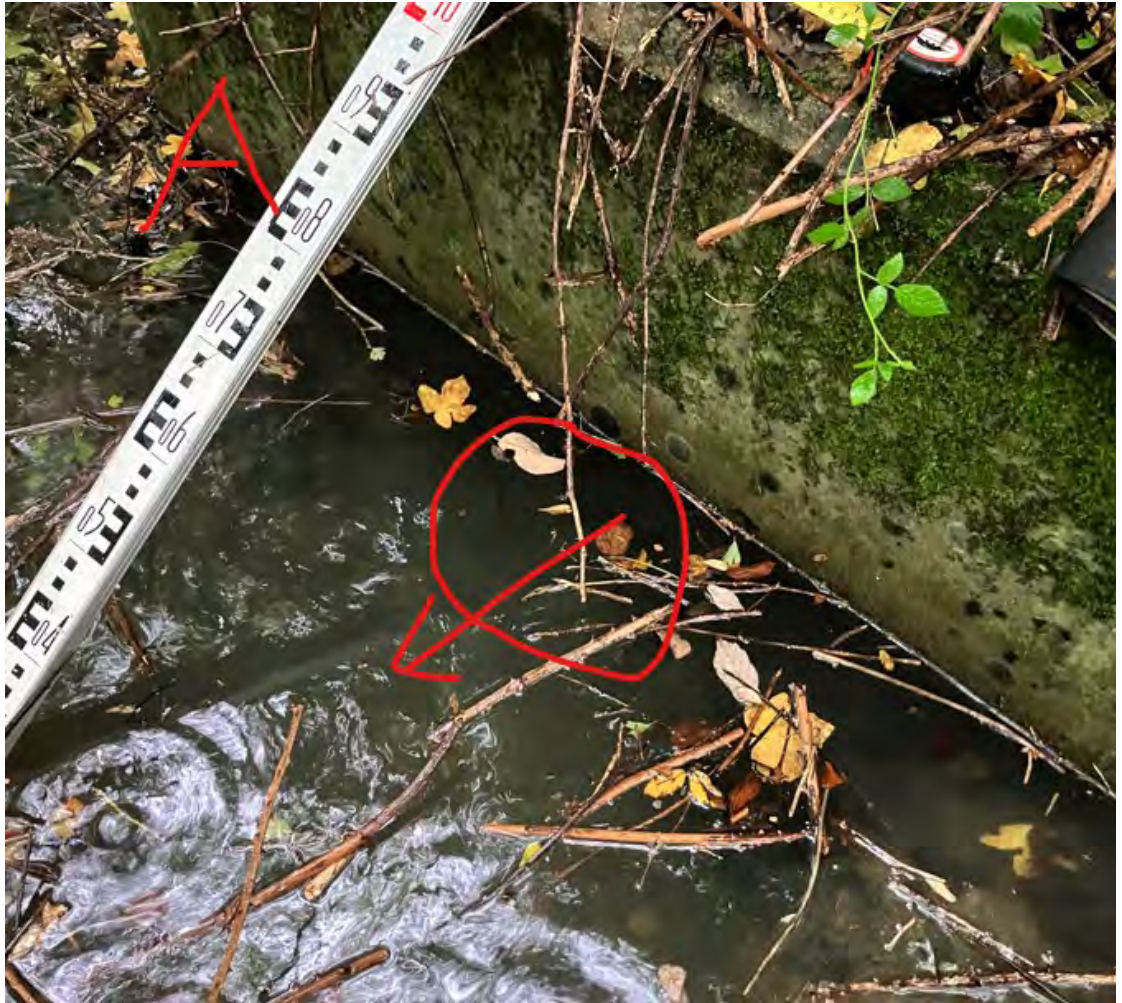
Culvert at  
northwest  
corner of  
site –  
estimated  
to measure  
200mm  
diameter

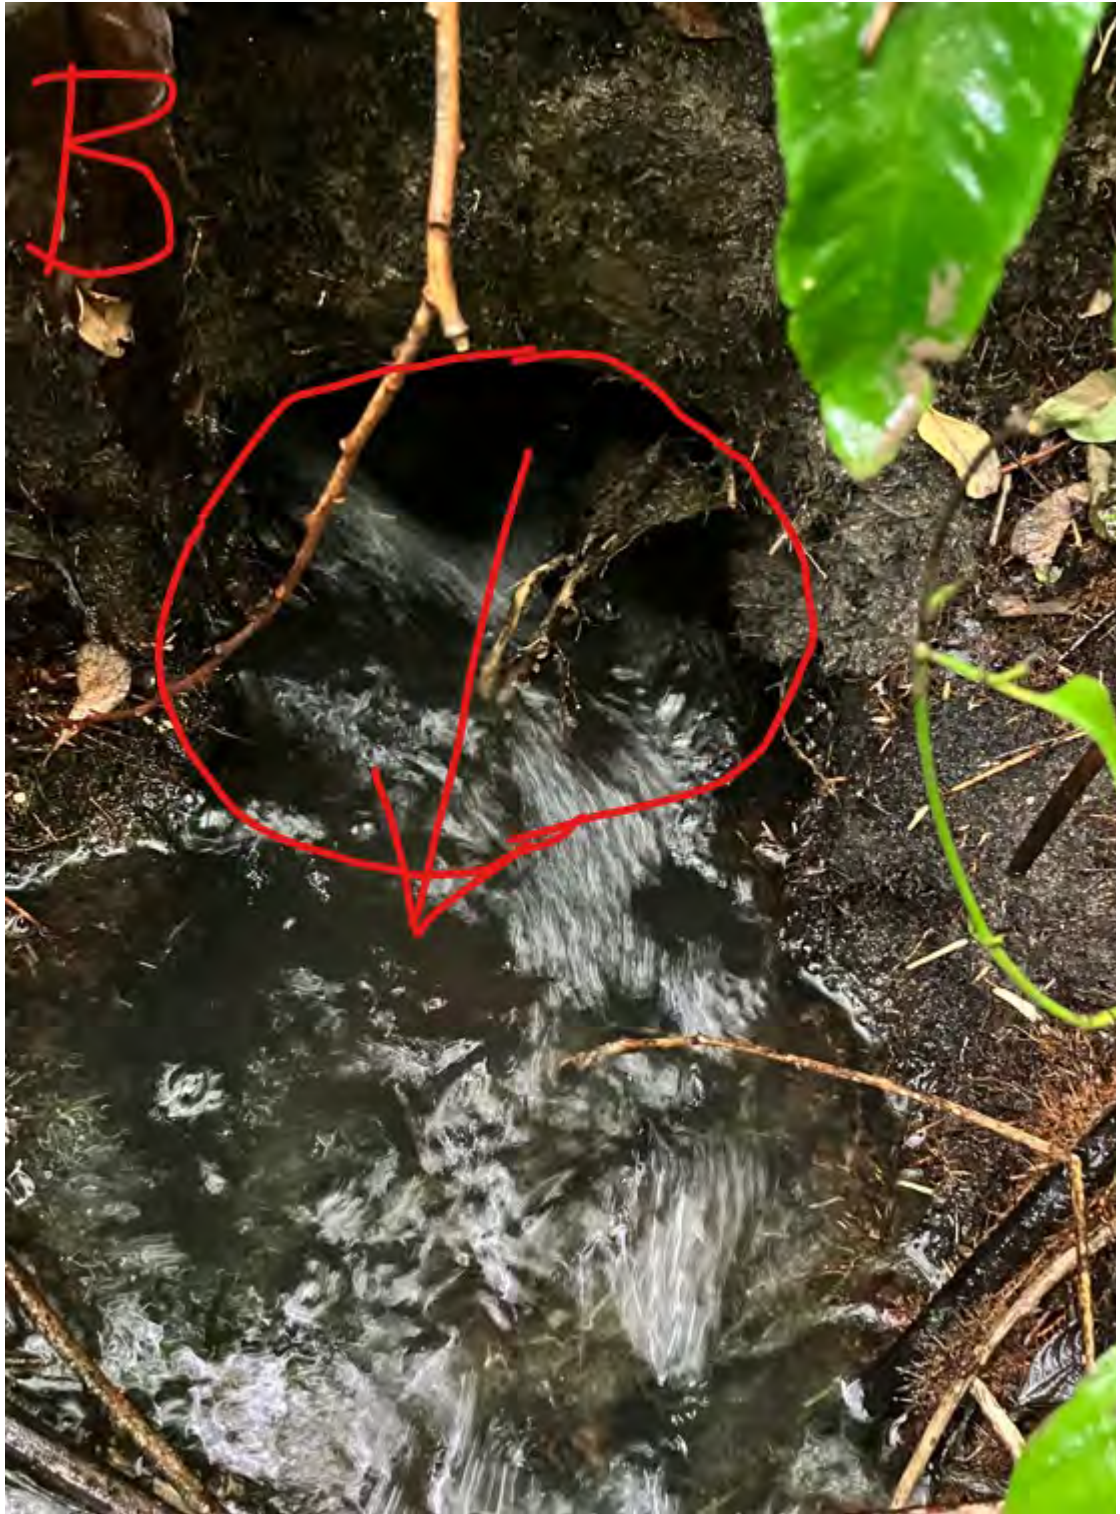
Culvert/outfall to the northeast of the site. Estimated as 200mm diameter

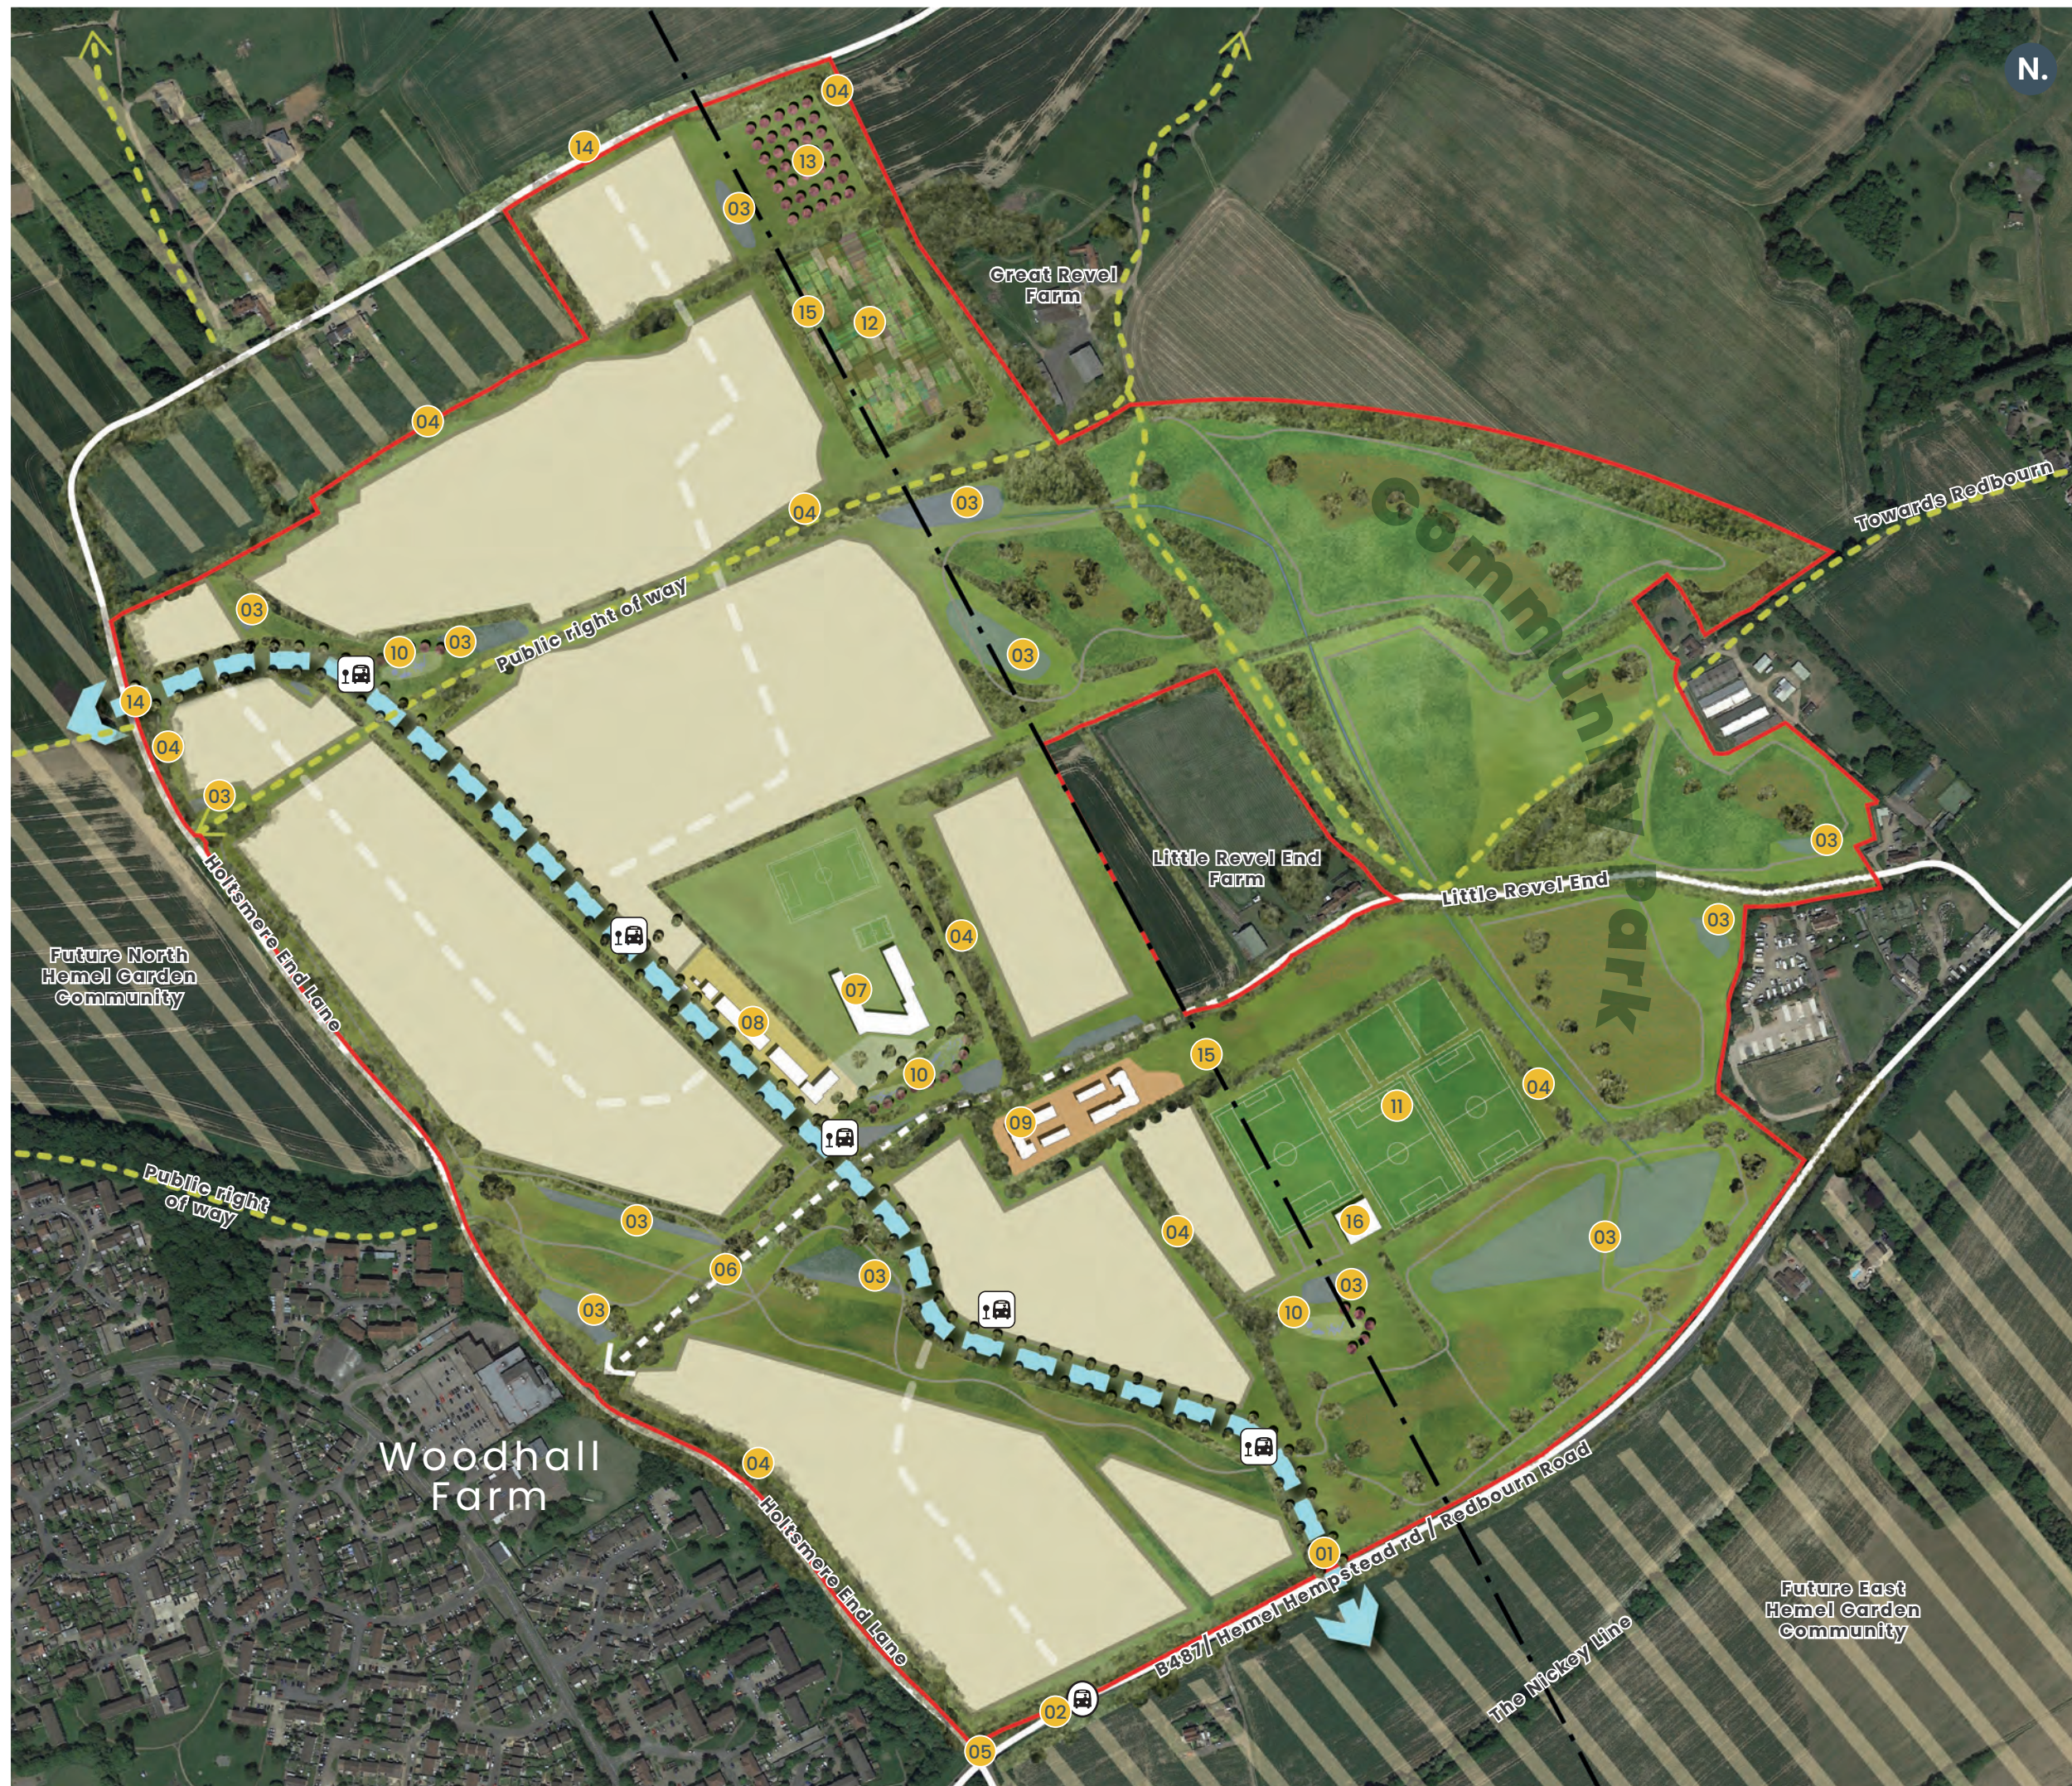
## Appendix G - Development Layout

- Key
- Site Red Line 103.75ha (TBC)
  - 01 Vehicular and pedestrian access point
  - 02 Bus only access
  - 03 Sustainable drainage system (SuDS)
  - 04 Retained hedgerow planting
  - 05 HGC Green loop – pelican crossing
  - 06 Active travel: cycle and pedestrian route
  - 07 Two form entry primary school
  - 08 Local Centre (with mobility hub)
  - 09 Care
  - 10 Play area
  - 11 Sport Pitches
  - 12 Allotments
  - 13 Community orchard
  - 14 Future access links
  - 15 High voltage power line
  - 16 Changing rooms
- Indicative bus stop
- STC (Sustainable Transport Corridor)
- Indicative primary connections
- Existing Roads
- PRoW
- Land Uses
- Residential
  - Local Centre & Mixed Use
  - Wider HGC Development Areas

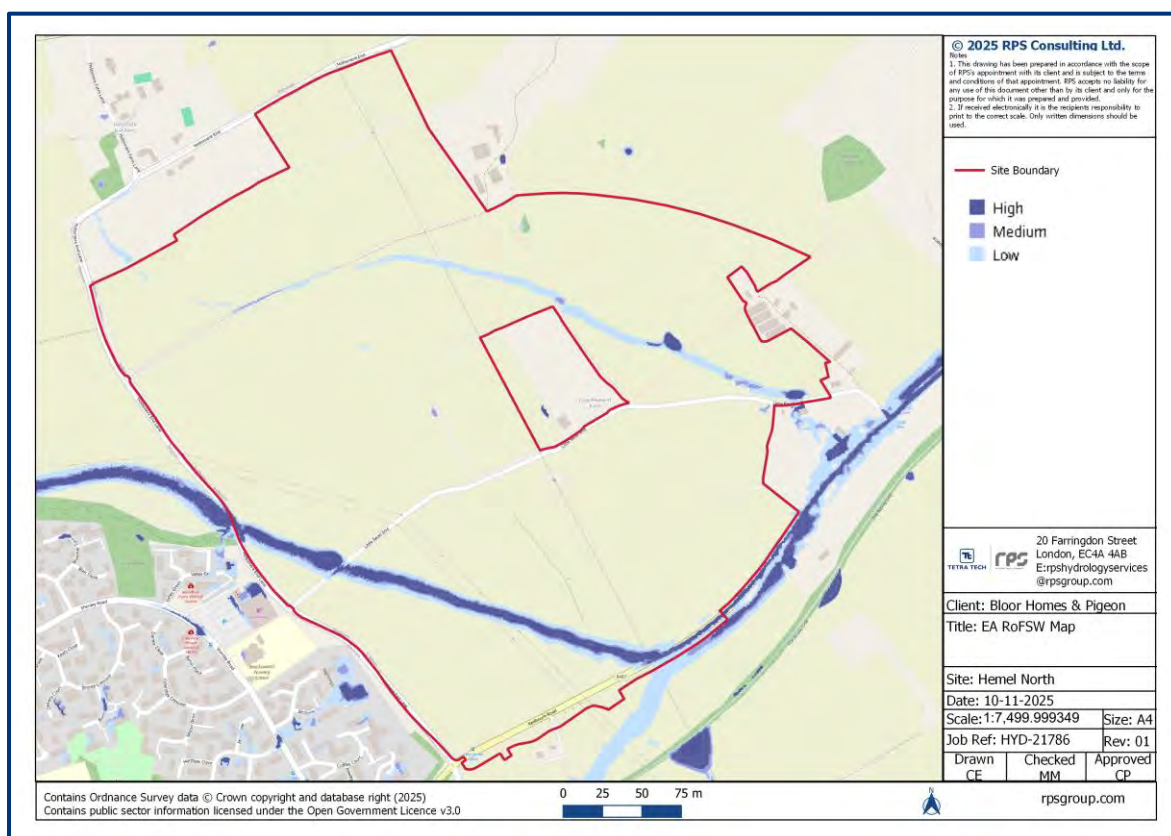
**Figure 1. EA Risk of Flooding from Surface Water**

- 1.3.7 The EA Flood Map for Surface Water<sup>1</sup>, shown in Figure 1 indicates two distinct flow paths (located at north and south of the site boundary) of 'Low' to 'High' surface water risk.
- 1.2 As of January 2025, the EA also provides data for Flood Map for Surface Water including climate change extents, which consider the 'Central' climate change allowance for the 2050s epoch (2040-2060). Within the climate change scenario, it can be noted that the 'Low' to 'High' risk areas of surface water flood risk have larger extents.

- 1.3.1 The EA Risk of Flooding from Surface Water (RoFSW) map is derived from a national model and can be considered relatively broadscale; it may not contain accurate representation of key hydraulically significant features at a site-specific scale. As such it is not always considered reliable to capture site-specific flood risk conditions.

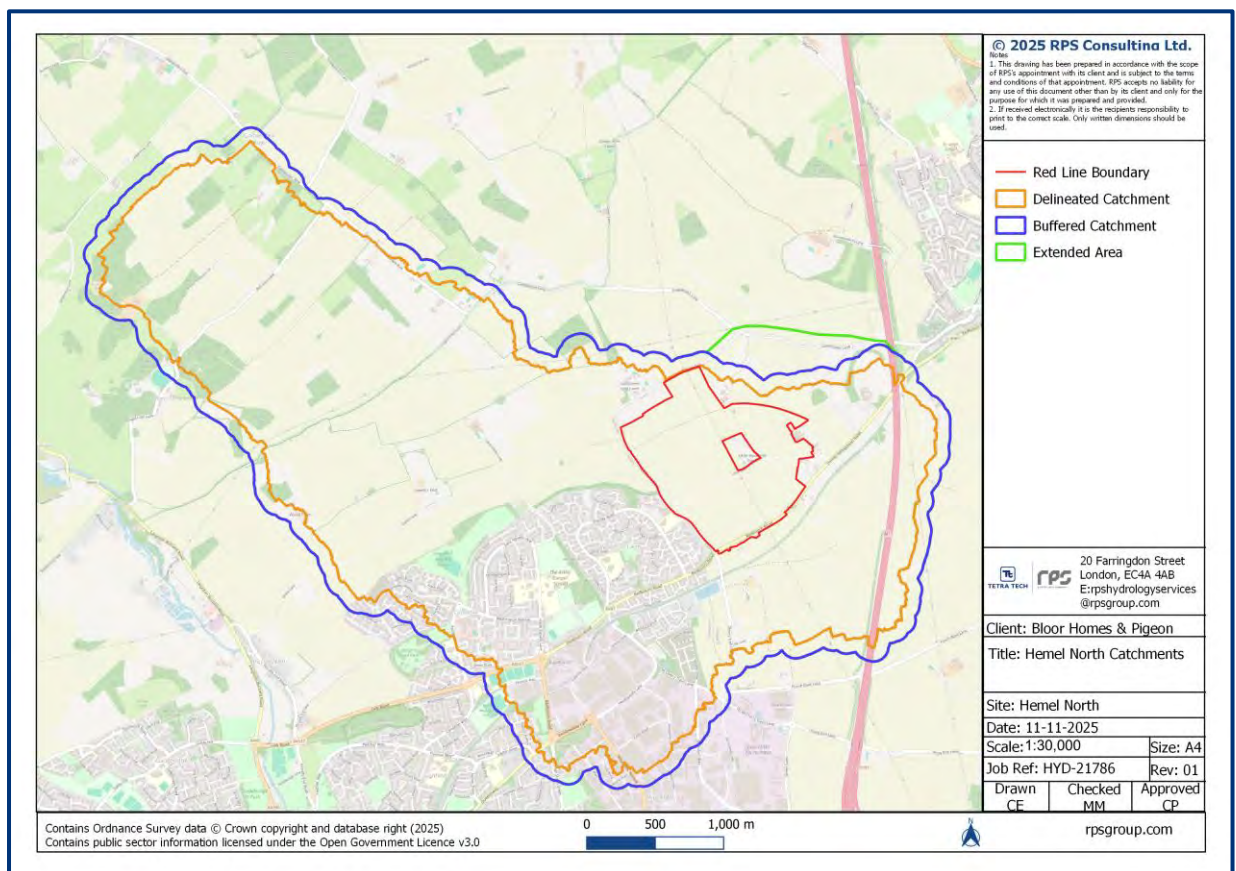
Figure 2. Catchment Boundary

- 2.2.4 The derived catchment boundary is presented in Figure 2.

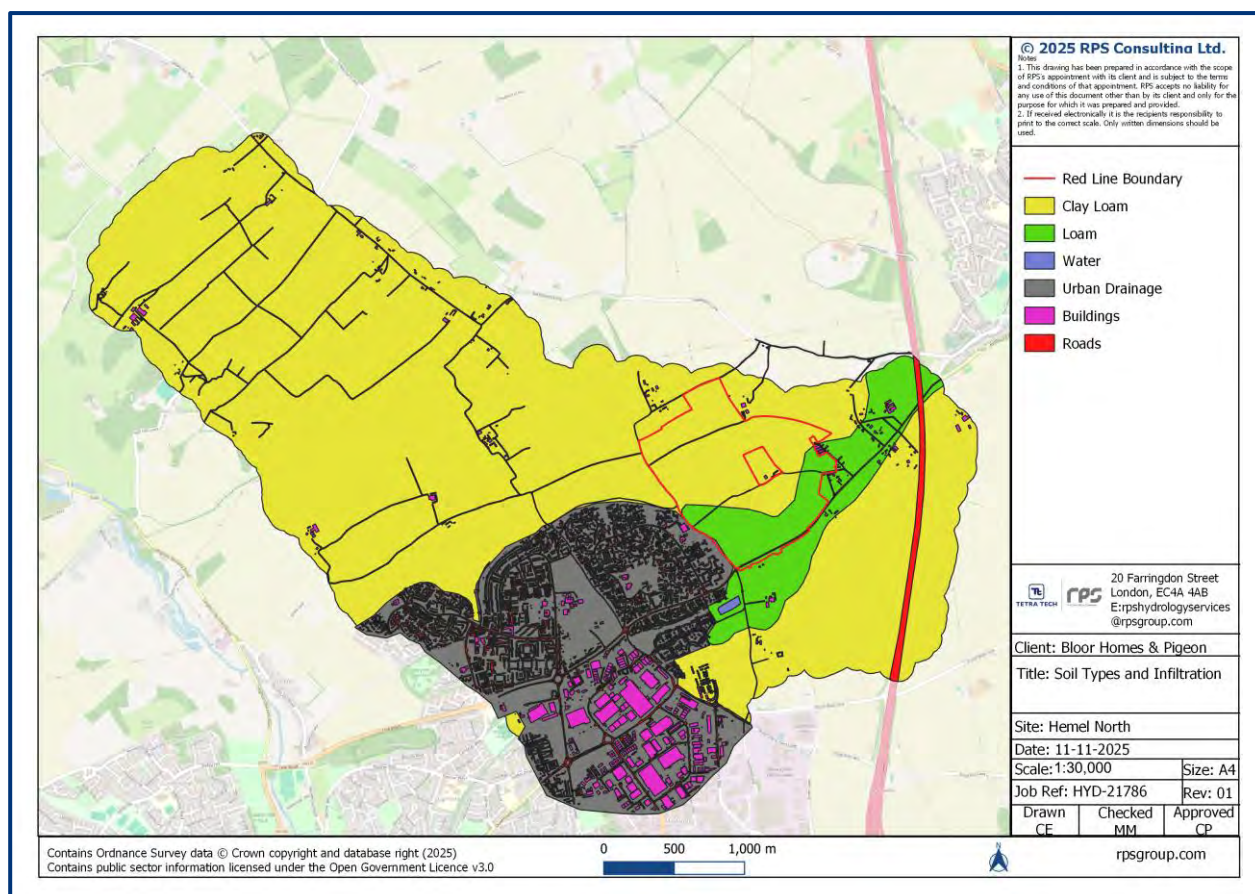
**Figure 3. Soil Types within Catchment**

- 2.8.4 An impermeable layer has been defined covering the roads and buildings present in the model. A Soil Type number of '99' has been applied to this layer (shown in Figure3). This represents the fact that buildings and roads have no infiltration.

- 2.8.6 Figure 3 shows the soil types and urban areas input into the model.

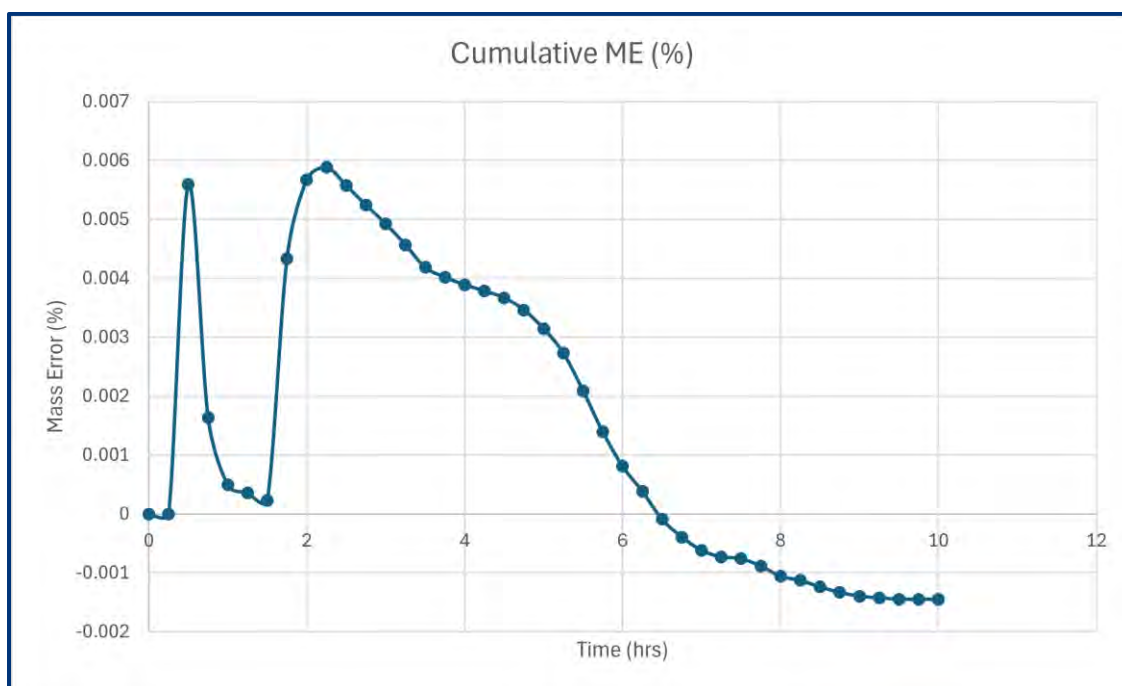
**Figure 4. Mass Error in 1 in 100-year +40% CC event**

2.12.1 The cumulative mass error (ME) is outputted during the model simulation. This value provides an understanding of the stability of the model as well as the robustness of the model and its ability to stimulate a flood event accurately. A model is considered healthy if it falls between the recommended range of +/- 1% throughout the simulation.

2.12.2 Figure 4 presents the mass error during the 1 in 100-year +40%CC return period.

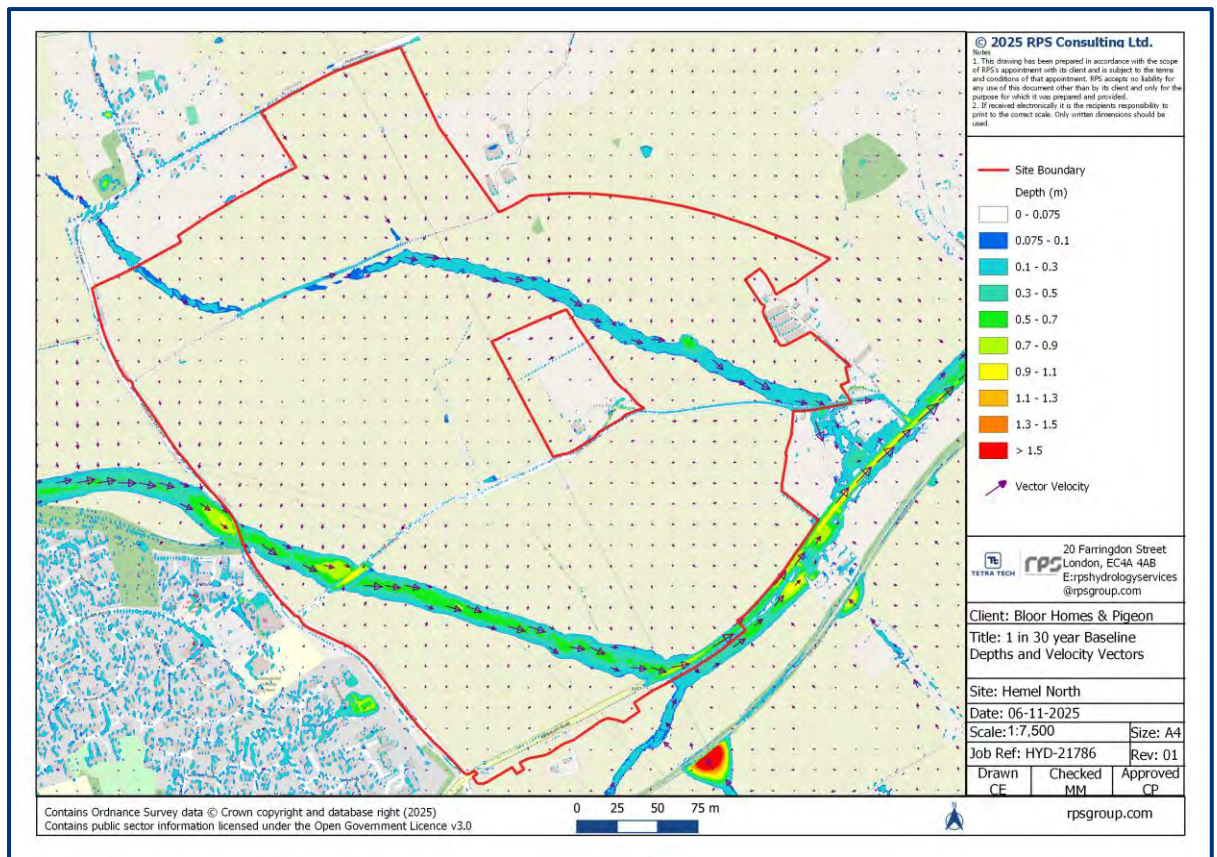
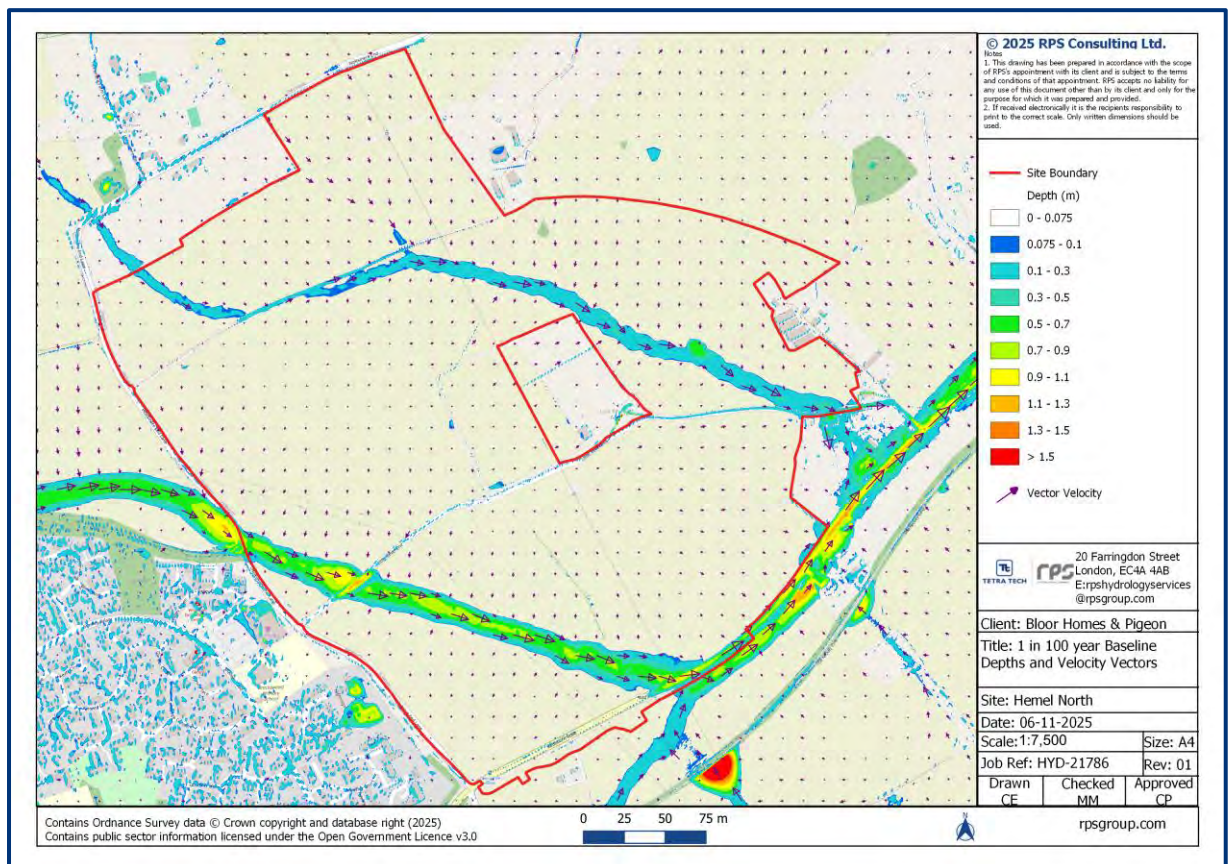
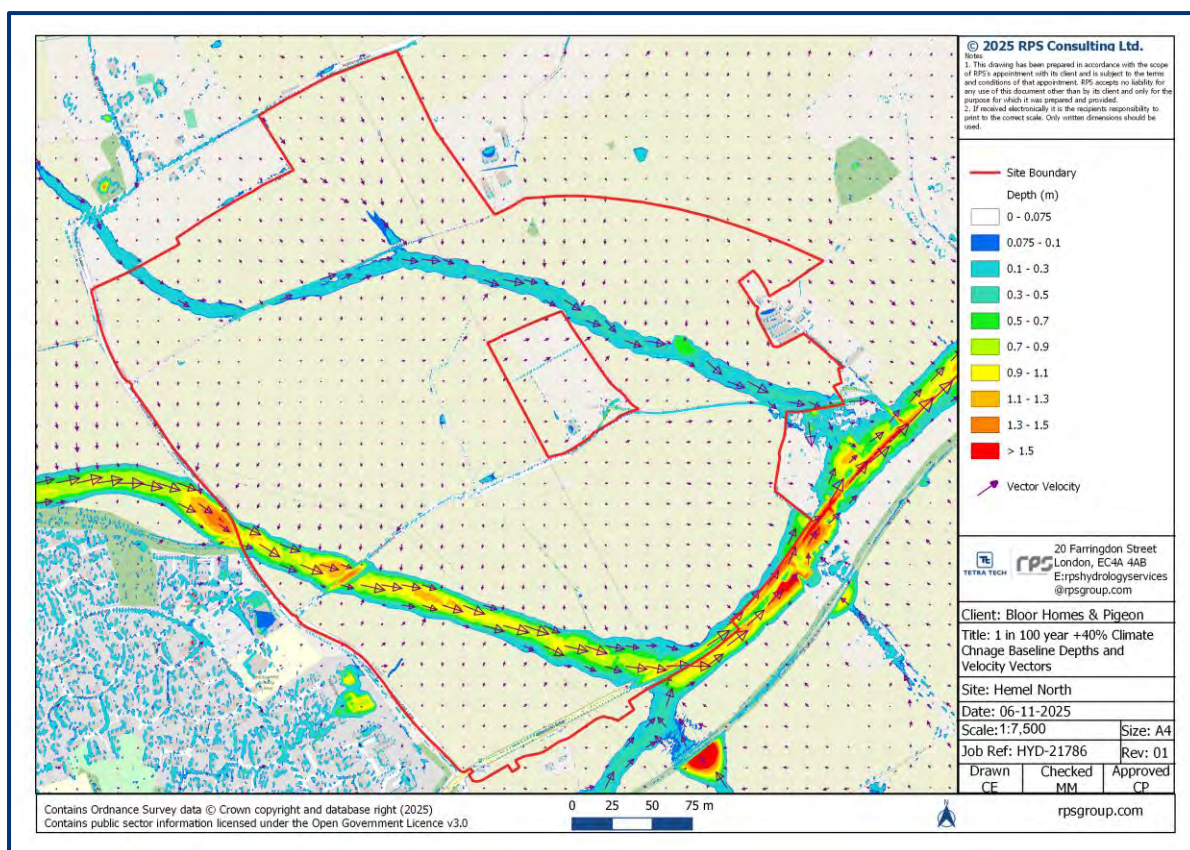
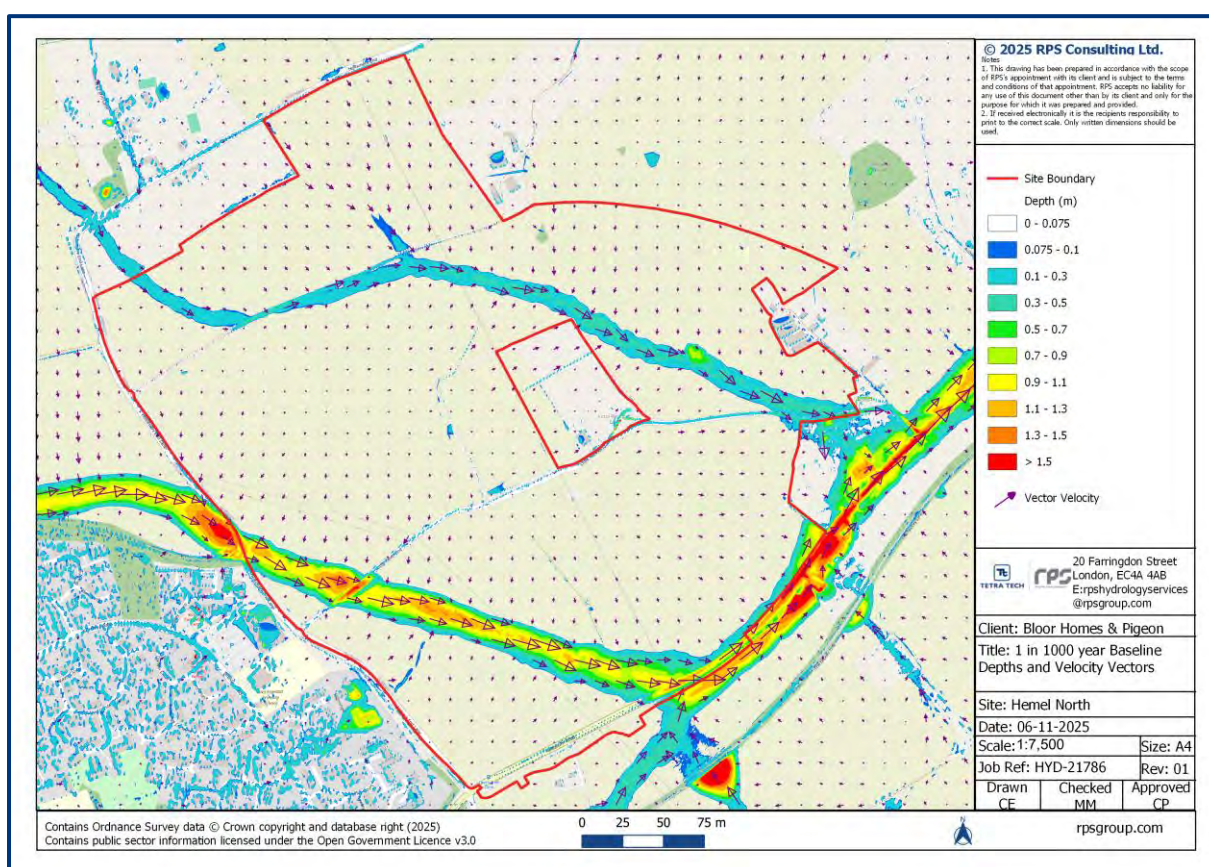
- 3.2.1 The model has been run for pre-development existing conditions of the site.
- 3.2.2 Figures 5, 6, 7 and 8 shows the maximum flood depths and velocity vectors for the 1 in 30-year year, 1 in 100-year and 1 in 100-year + 40% Climate Change and 1 in 1000-year scenarios respectively. The results and flow mechanisms are relatively similar throughout the return periods with some additional water ponding in the more extreme flood events. Two clear flow pathways are identified in all return periods and exhibit similar velocities.

- 3.2.3 Water follows topography through the site from the northwest to southeast where it follows Hemel Hempstead Road east.
- 3.2.4 The model has been run for pre-development 'baseline' conditions of the site. Figure 9 shows the maximum modelled flood extents for the low (1 in 1000-year), medium (1 in 100-year) and high (1 in 30-year) scenarios based on EA scale and compared to the EA RoFSW mapping shown in Figure 10.

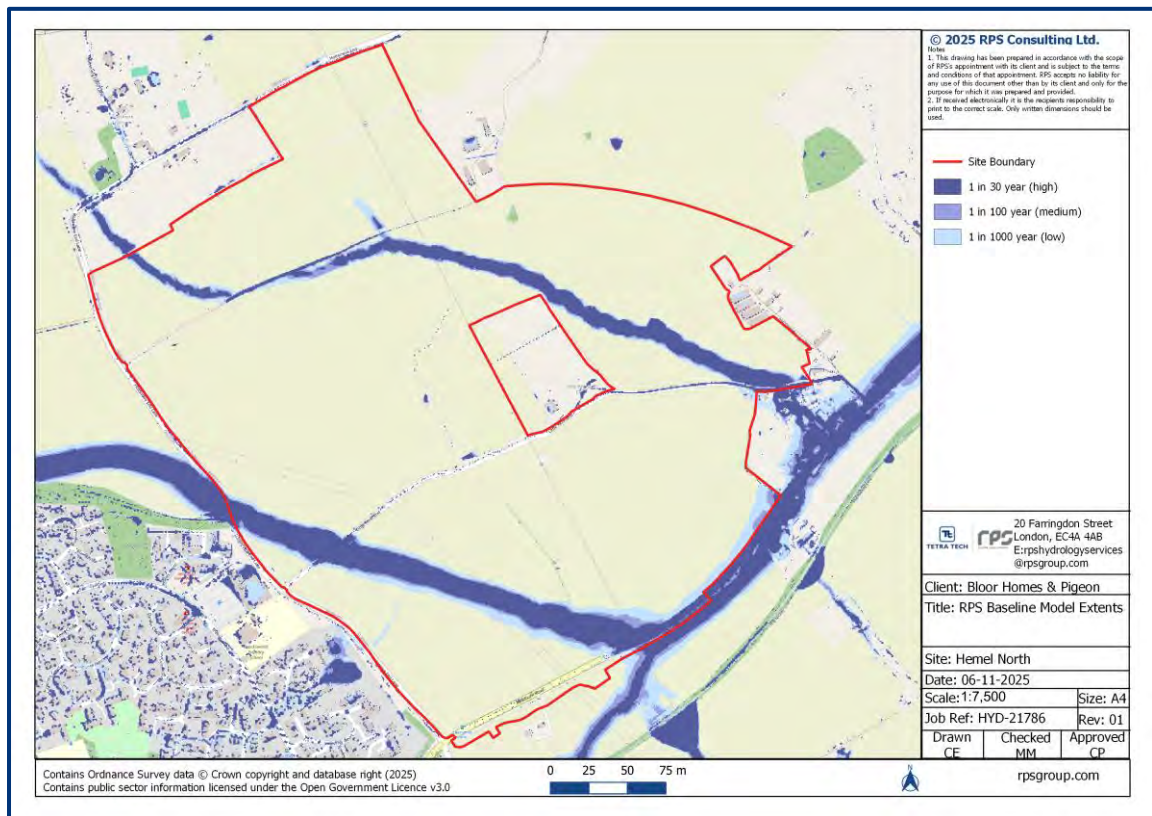
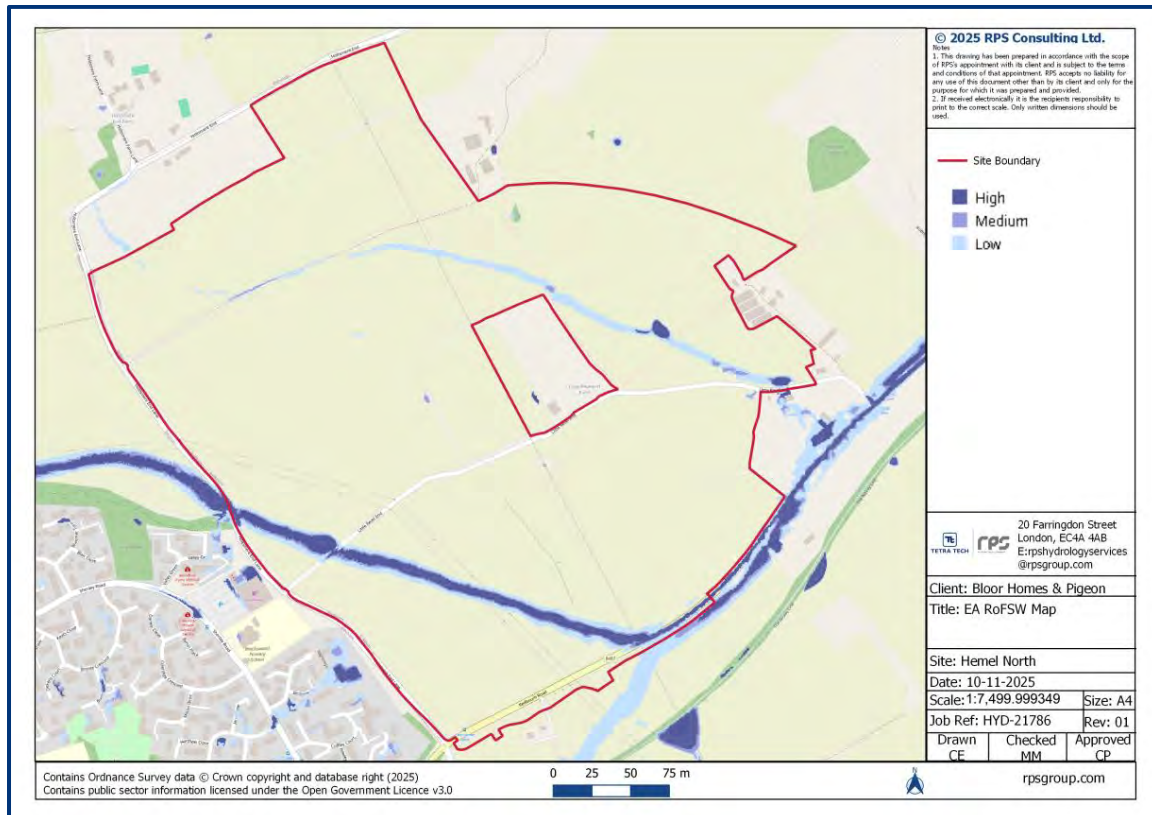
- 3.3.1 There are no reliable historic surface water flood risk records against which to calibrate the model. A sense check comparison of the RPS model results with the EA RoFSW mapping has been undertaken and shows a similar pattern of predicted flood risk mechanisms, see Figures 9 and 10.
- 3.3.2 The areas of standing water and dips in topography observed during the site visit are replicated in the modelling.

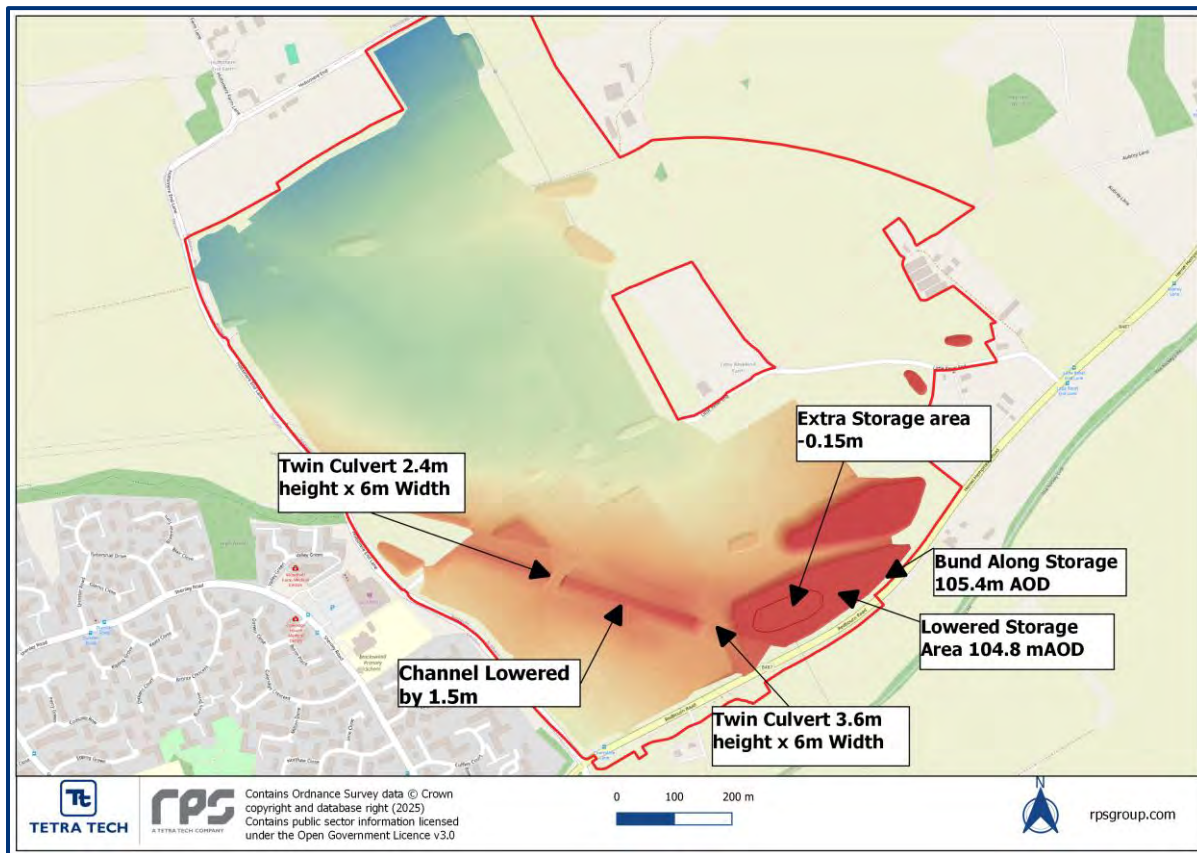
**Figure 11. Features within the Proposed Model**

- 4.2.2 The representation of the proposed development scheme modelling is discussed below and shown in Figure 11. More detailed plans are shown in the Appendices of the FRA and submitted alongside this planning application.
