PROJECT TITLE  
LAND AT REDBOURNE ROAD  
HEMEL HEMPSTEAD, HP2

DRAWING DETAIL  
UTILITIES AND DRAINAGE SURVEY.  
SHEET 31 OF 31

### **Land Adjacent to Holtsmere End Lane (South)**

This report presents the findings of a Ground Investigation undertaken to initially assess the infiltration and drainage characteristics of the soils throughout the area. Pertinent findings and conclusions may be summarised as follows:

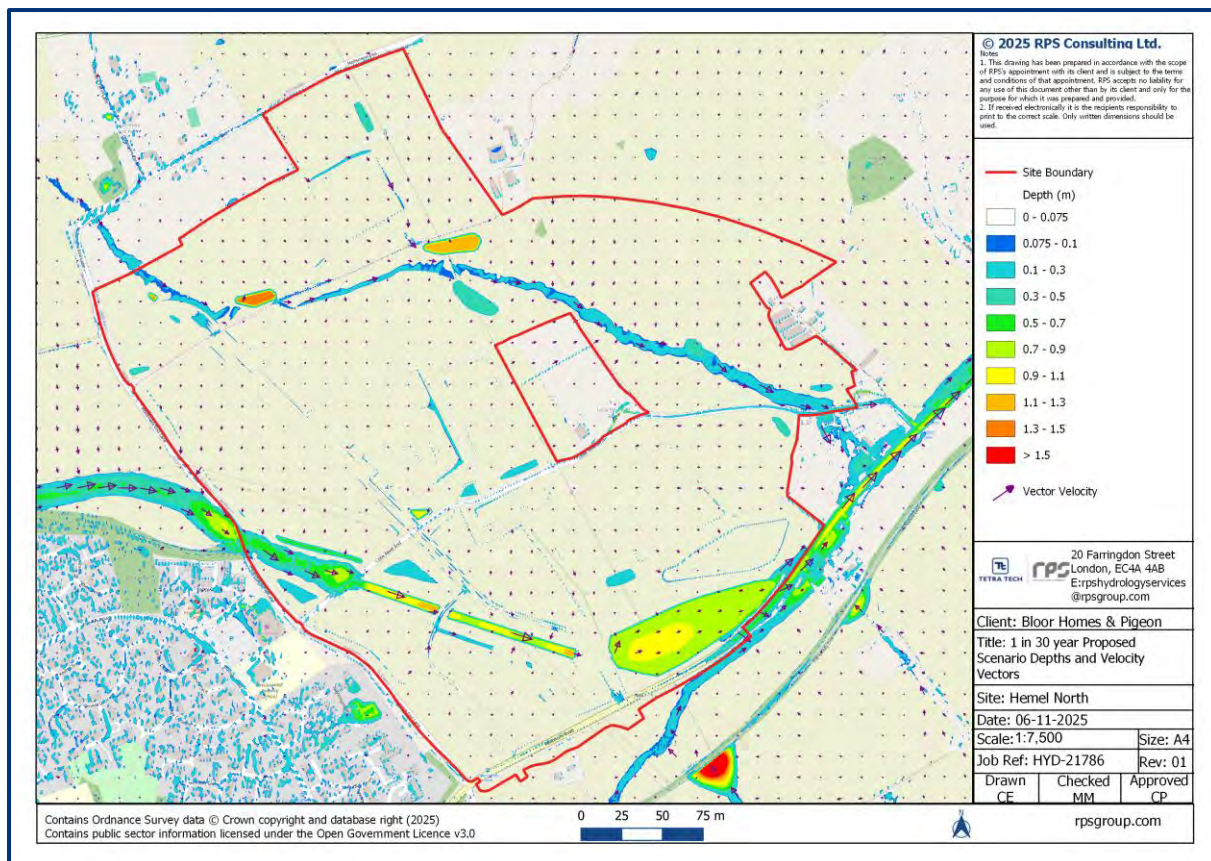
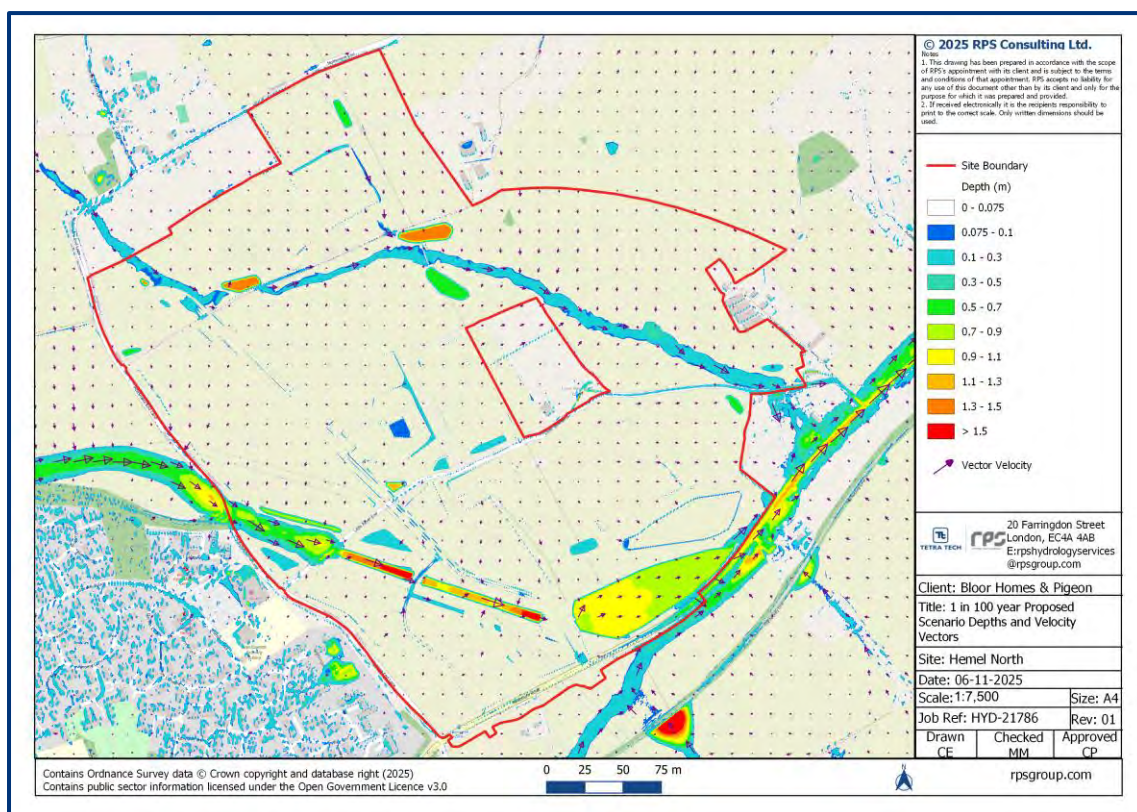
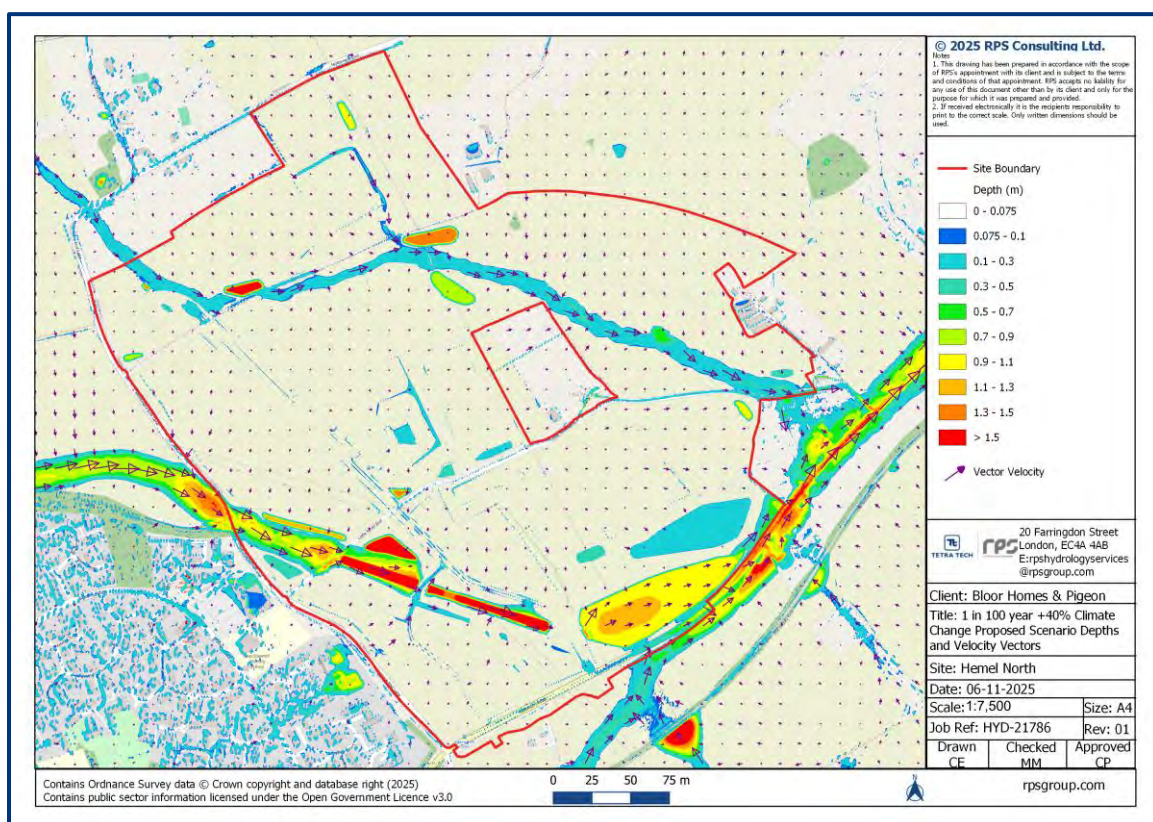
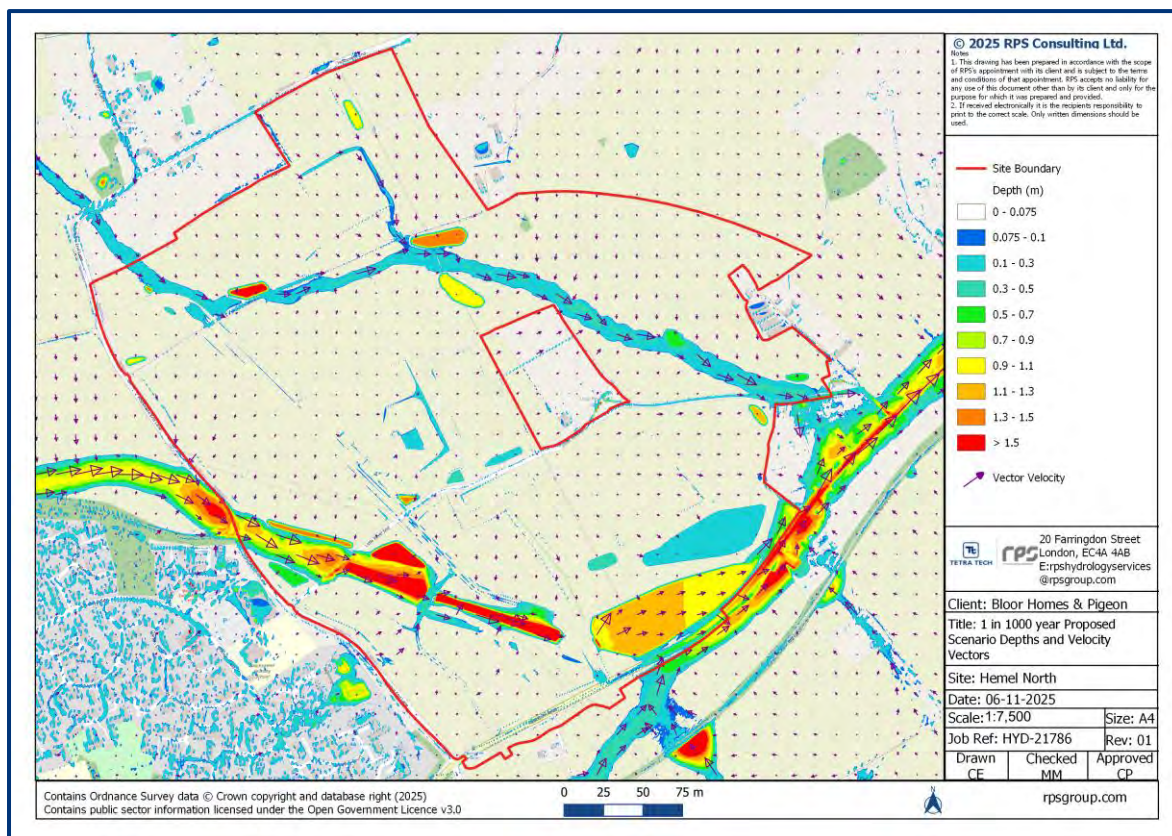
- 4.3.3 The model has been run for the post development conditions of the site for 1 in 100-year+40% climate change.
- 4.3.4 Figures 12 to 15 show the flood depth and velocity vector maps for the 1 in 30-year, 1 in 100- year, 1 in 100-year+40% climate change and 1 in 1000-year events for the proposed scenario. Velocity vector arrows show how water is steered by areas of lowered and raised ground through the site.

- 4.3.5 During the 1 in 30-year and 1 in 100-year events, water remains confined within the lowered channel. In the 1 in 100-year +40% climate change event (design event) shallow depths of up to 300mm are seen in a small portion of the road, this is expected to be managed by highways drainage.

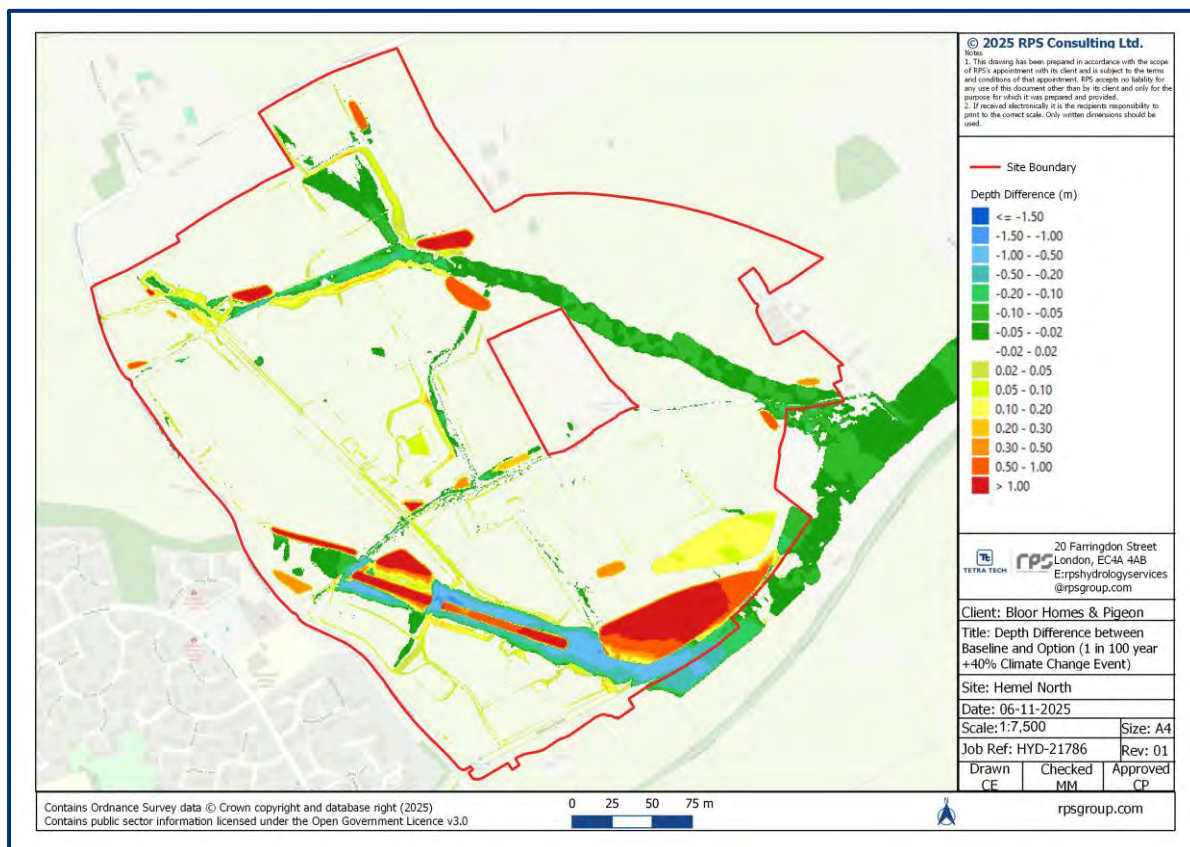
**Figure 16. Depth Difference - 1 in 100-year +40% CC**

- 4.3.6 The flood depth difference map is produced by subtracting the baseline depths from the proposed depths. The maximum difference in flood depth between the baseline and development scenario is shown in Figure 16. Increases in on-site depths are seen where water is being stored in the proposed storage area. In addition, where water is held back via culverts, as expected.
- 4.3.7 Outside of the site, there is no change in the upstream off-site depths. Downstream, there is a minor decrease in flood depths by up to 0.1m.

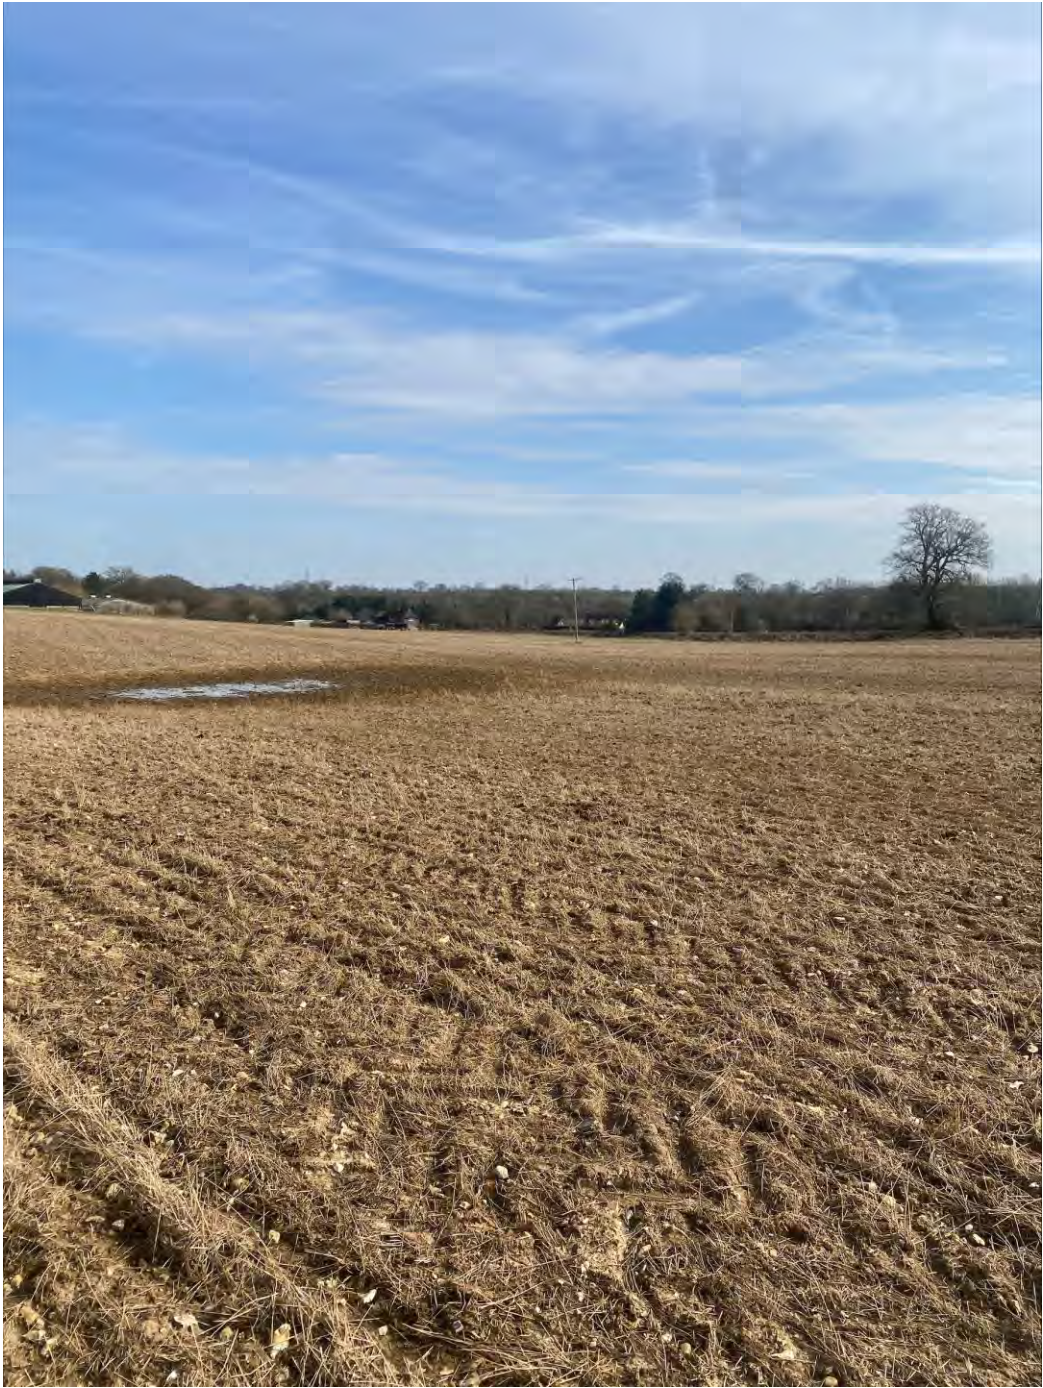
| Description | Photo |
|---|---|
| Entry to the site and overall topography - Pooling in low points | |

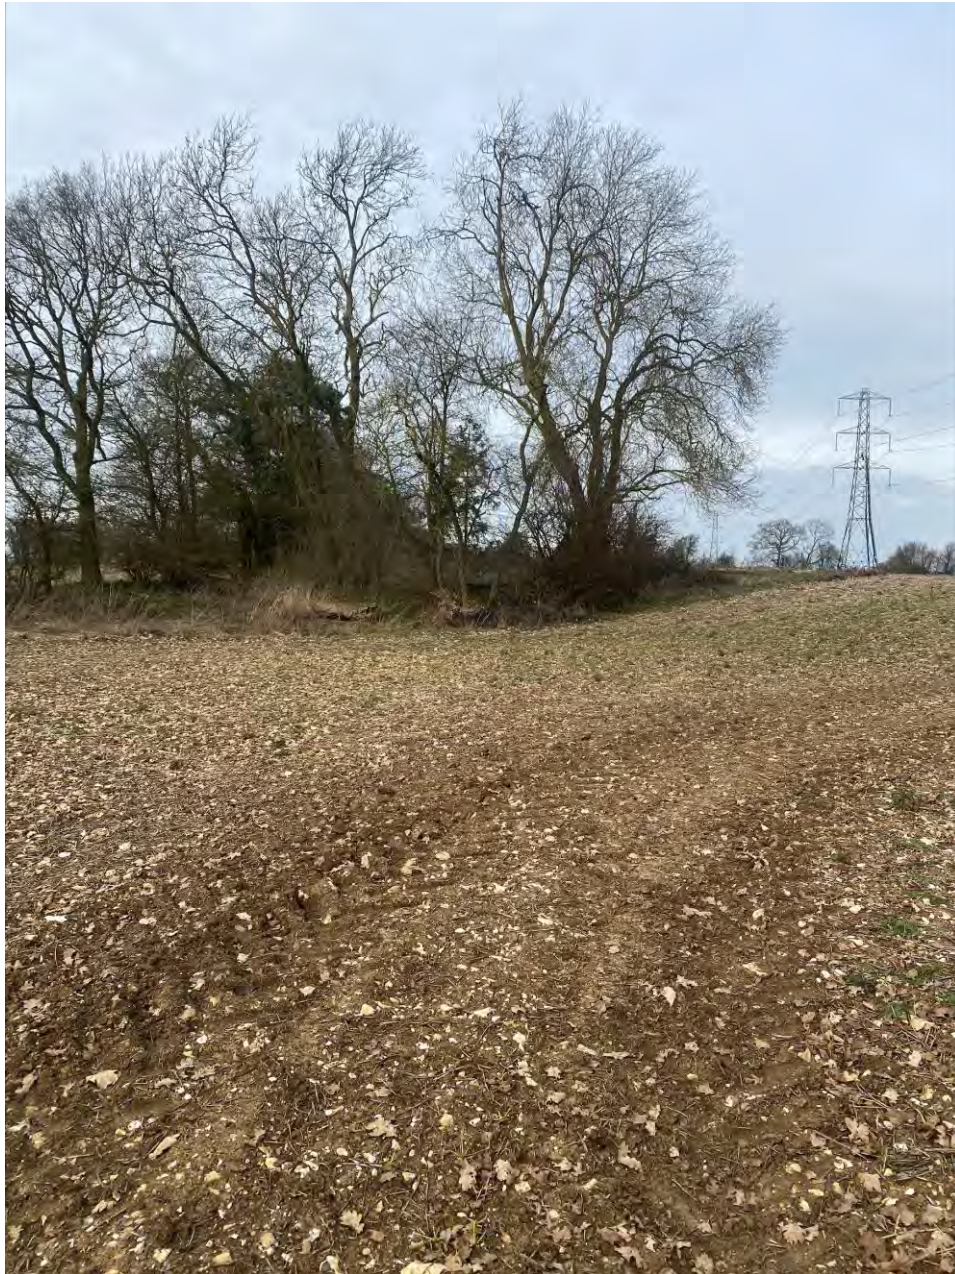
Dip near  
centre of  
site where  
vegetation  
present,  
this is seen  
on LiDAR

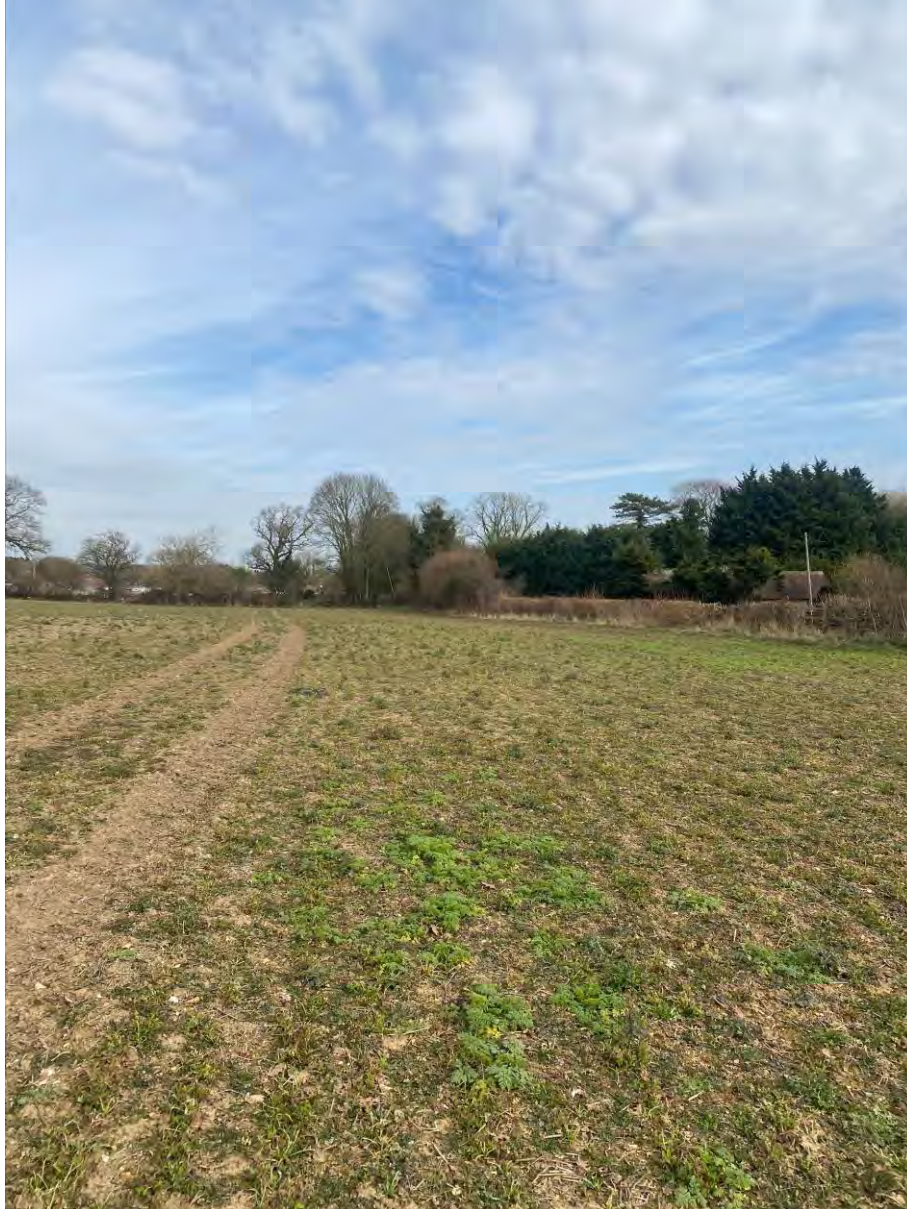
Looking to  
the east  
corner  
where flow  
path leaves  
site

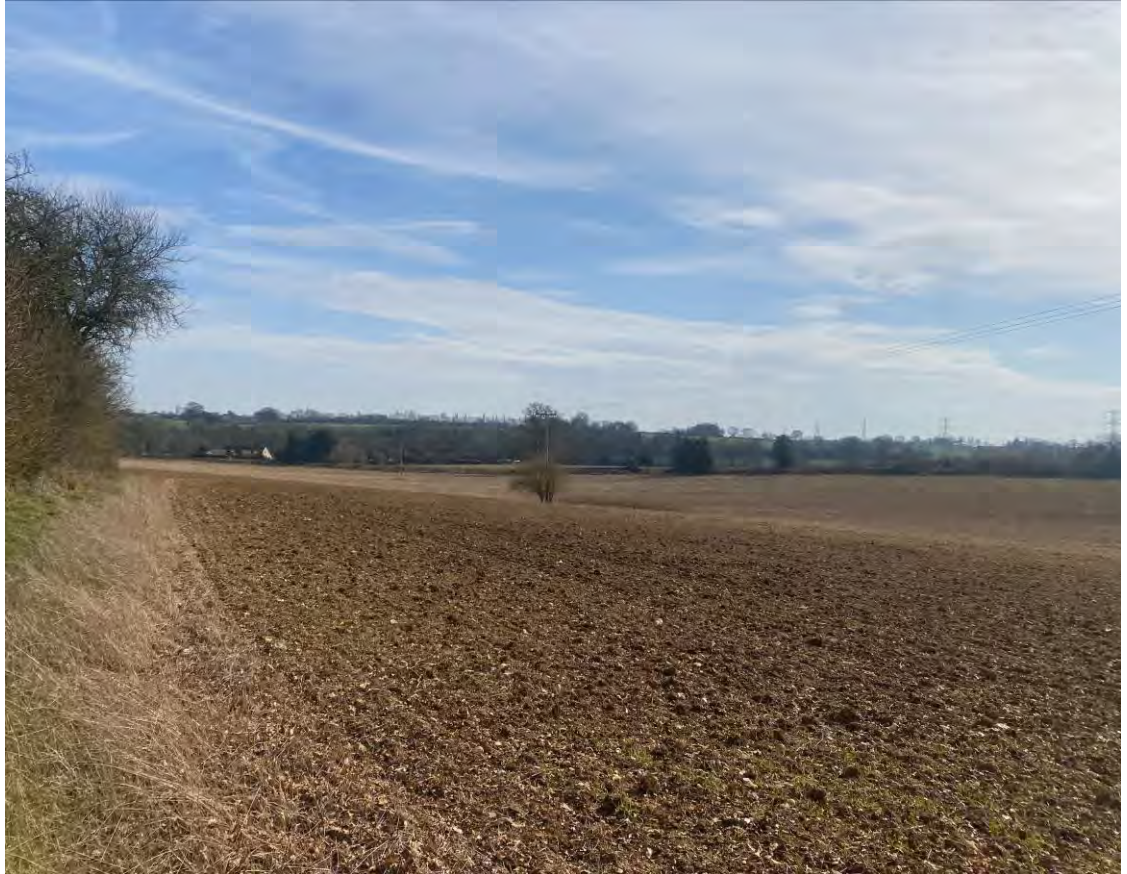
Dip in  
centre of  
land where  
flow path  
present

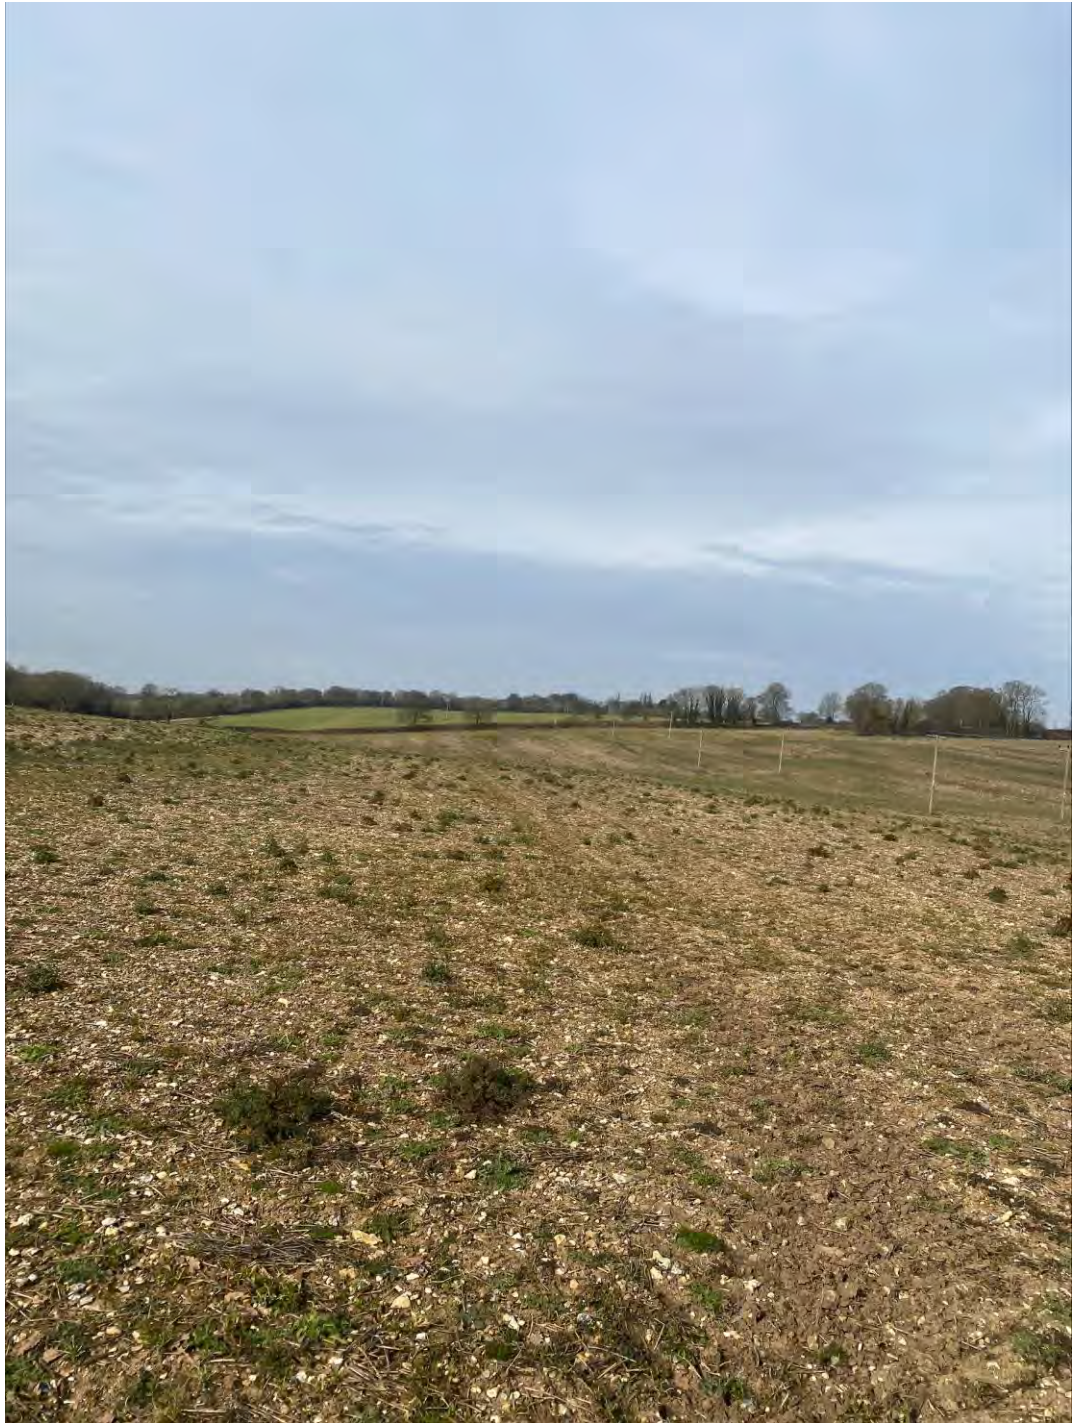
Another dip  
in  
topography  
where flow  
path seen

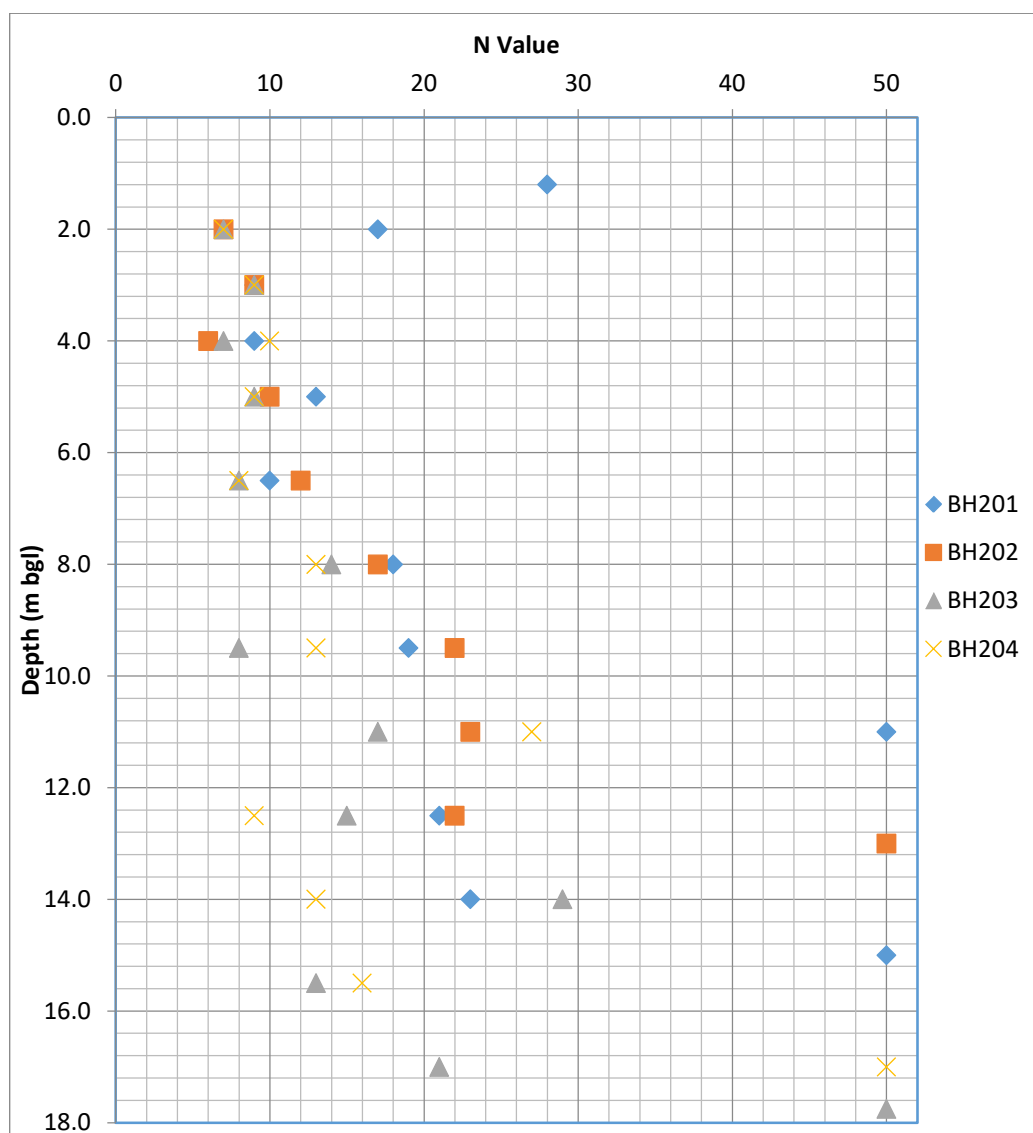
The results of in-situ geotechnical testing (SPT's) completed within the boreholes are summarised in the graph below.

The results of in-situ geotechnical testing show that 'N' values generally increase incrementally with depth as the strata changes from the matrix dominated Chalk to the more clast dominated Chalk. Drilling was abandoned in all of the boreholes due to refusals (i.e. 'N' =  $\geq 50$ ) within the deeper Chalk. These refusals were most likely due to the flint or denser chalk and / or intact fragments of chalk obstructing the drilling / testing equipment.

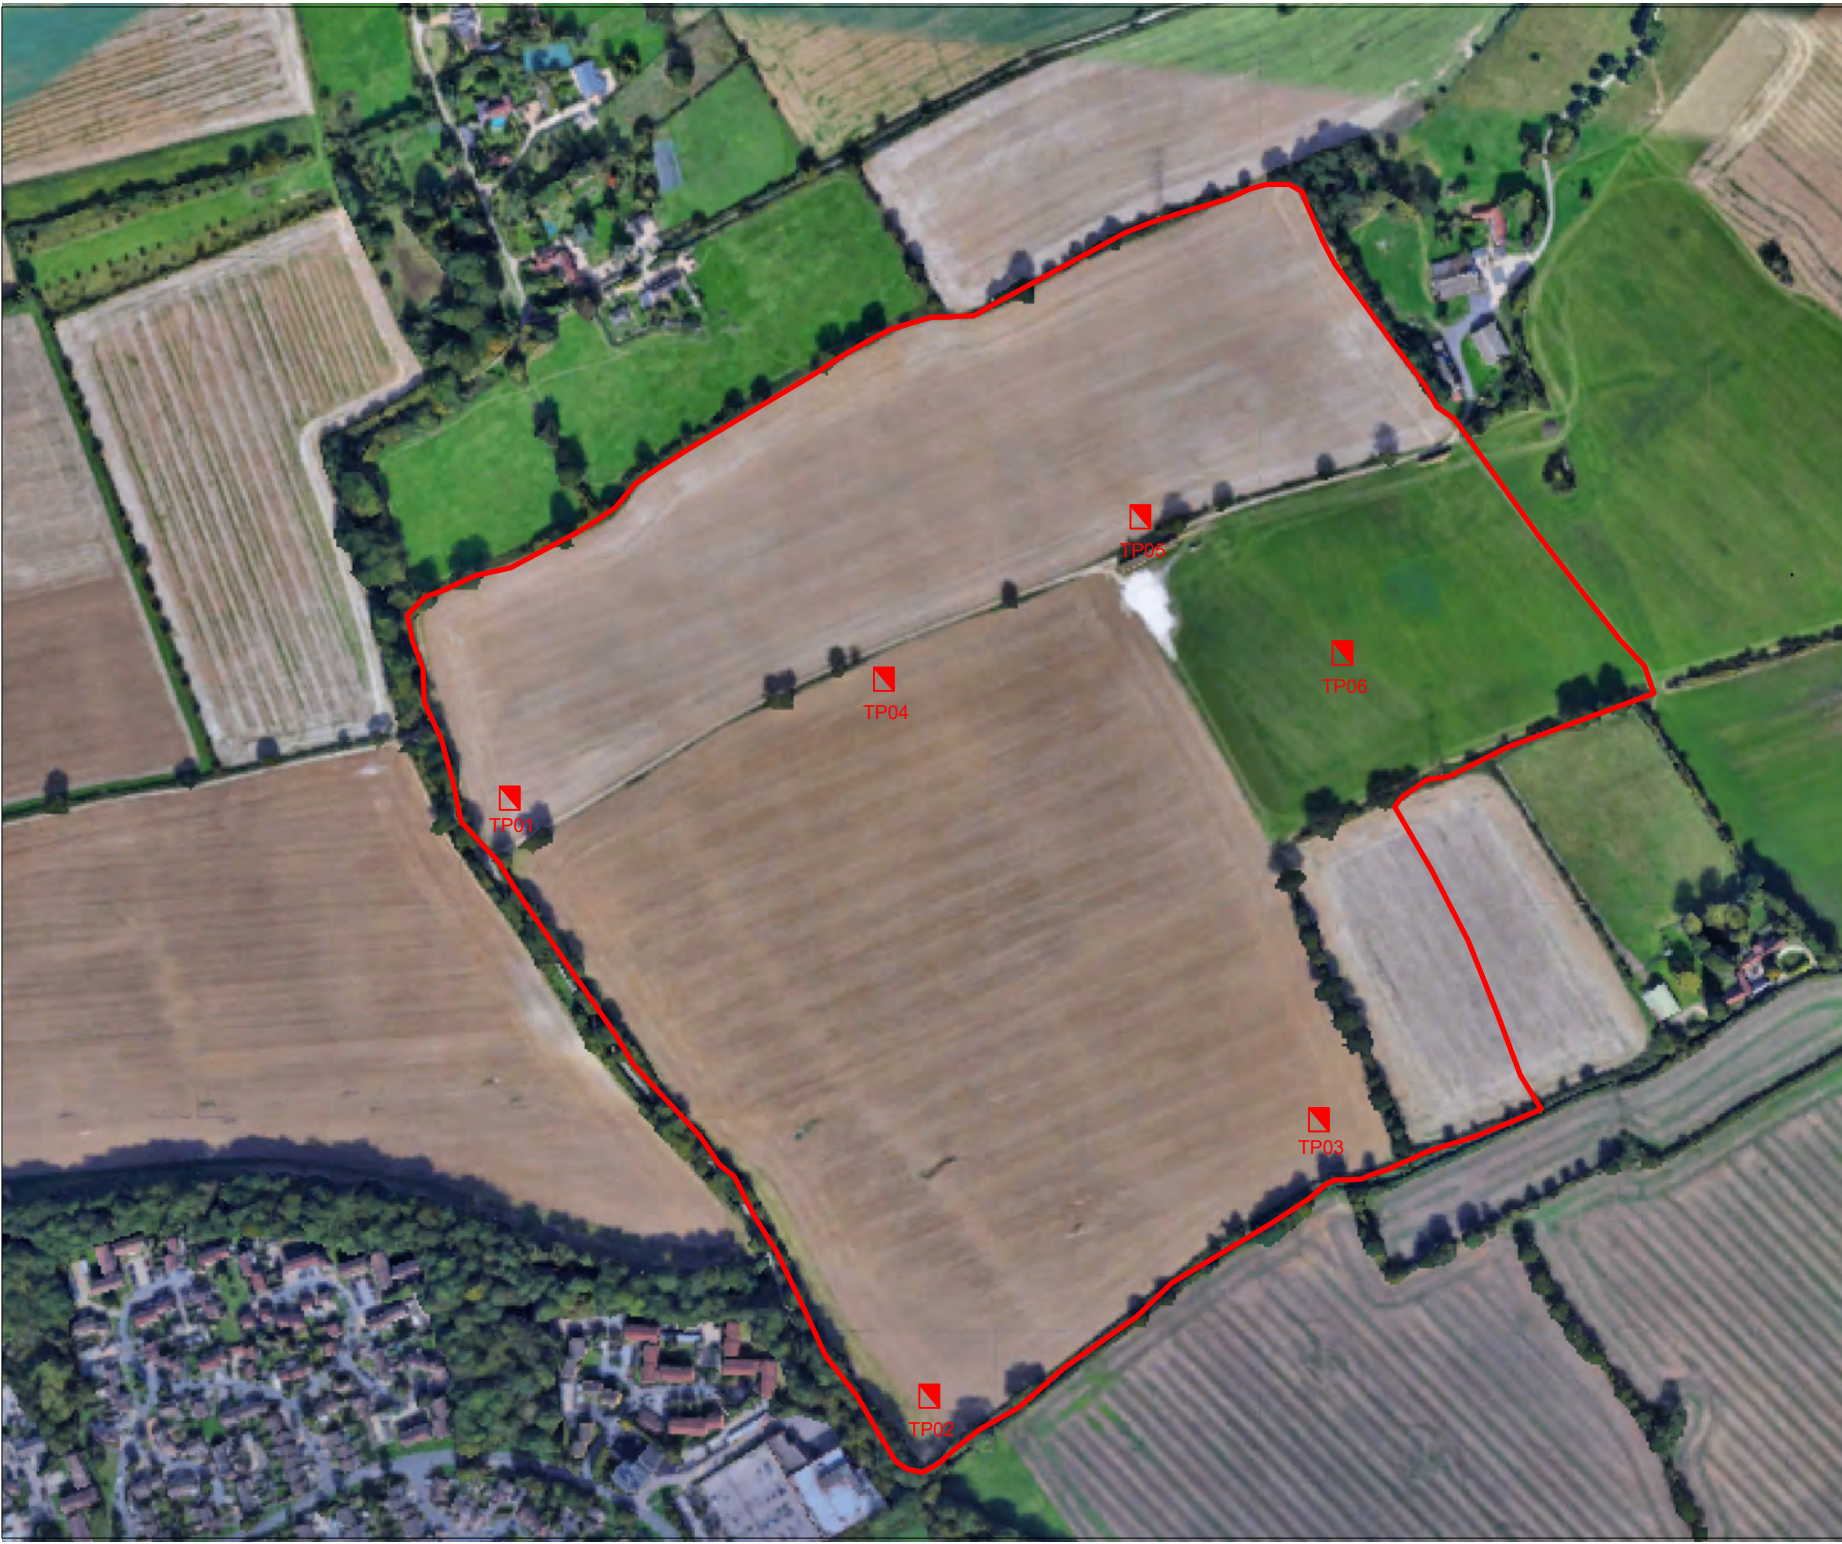
Title  
Figure 2 - Trial Pit Location Plan

KEY:  
— SITE BOUNDARY  
■ EPS TRIAL PIT / SOAKAWAY

The location of the trial pits is presented on Figure 2.

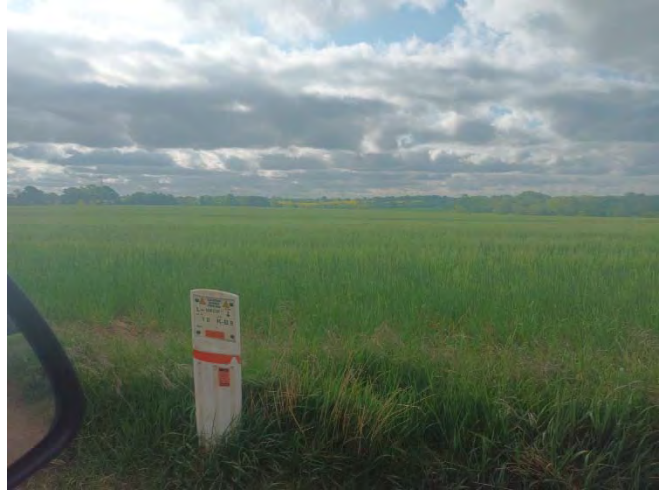
**Photo 2:** Facing south along access road, showing marker for high pressure oil pipe

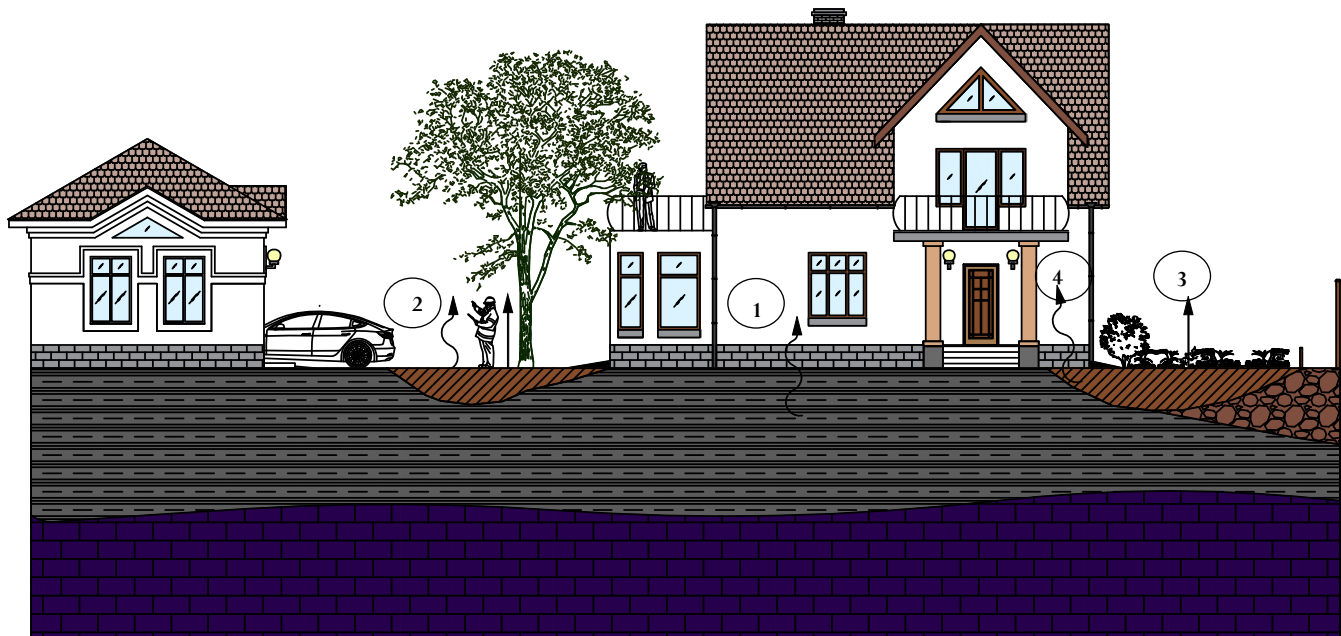
## Land Holtsmere End Lane, Hemel Hempstead – Illustrative Conceptual Site Model

1. Migration of radon gas to indoor & outdoor air
2. Direct / inadvertent contact with ingestion of soil & inhalation of fugitive dusts
3. Direct uptake and / or adherence of contaminated soil to vegetation and subsequent ingestion
4. Migration of ground gas to indoor & outdoor air (from on and off-site sources)
