## **Phase I Geo-Environmental Desk Study**

### **Land at Holtsmere End Lane**

Hemel Hempstead  
St Albans  
Hertfordshire  
AL3 7AW

**EPS Project Reference:** UK24.7212

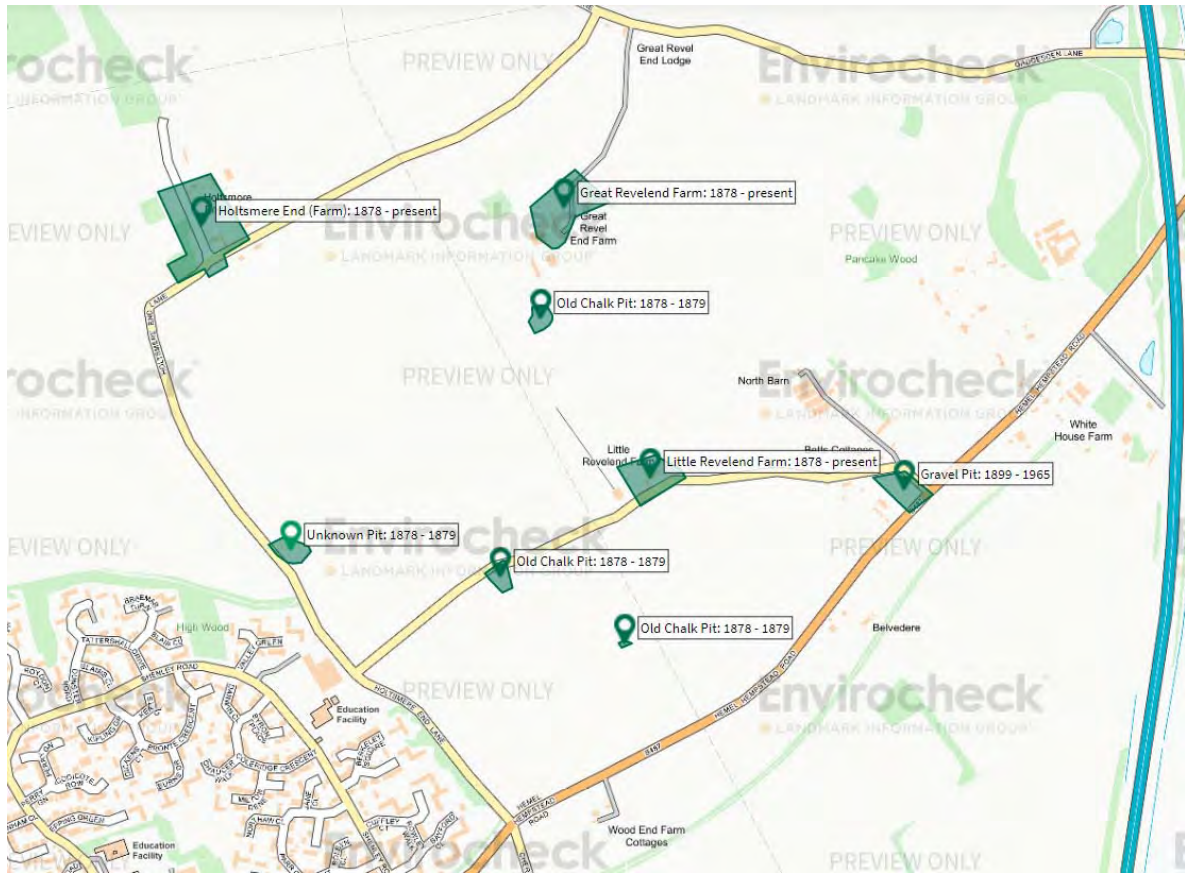
- Historical mapping shows that Holstmere End Farm, Great Revelend Farm and Little Revelend Farm have all been present from the late 1800's, with these holdings still present and active at the time of writing. Both Great Revelend Farm and Little Revelend Farm are excluded from the proposed development area.

- Three old chalk pits (two towards the south and one the north) are mapped from the 1870s, additionally an unspecified (unknown) pit is also mapped in the west of the northern area over the same time period, and this feature also coincides with an area of potentially infilled land.

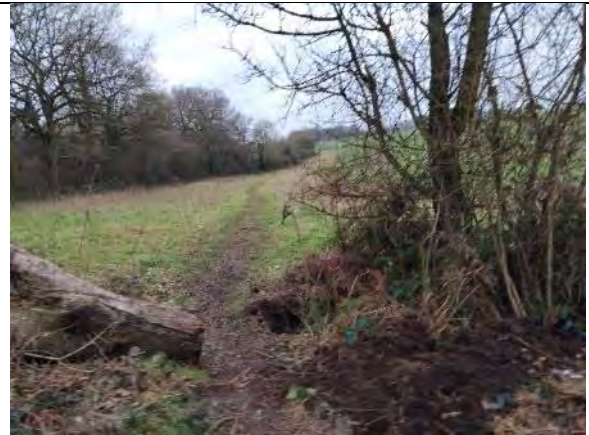
| <p>Photo 1: Image looking northwest across the southwestern corner of the northern site area.</p> | <p>Photo 2: Image looking northeast along the track through the northern site area.</p> |

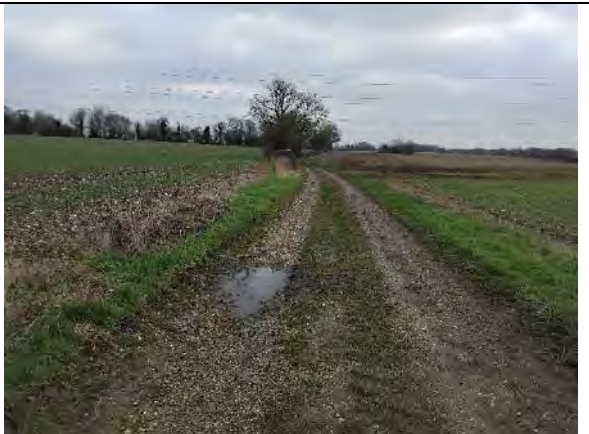
| <p>Photo 3: Image looking northeast along the track through the northern site area.</p> | <p>Photo 4: Image looking northeast across the central eastern field of the northern site area.</p> |

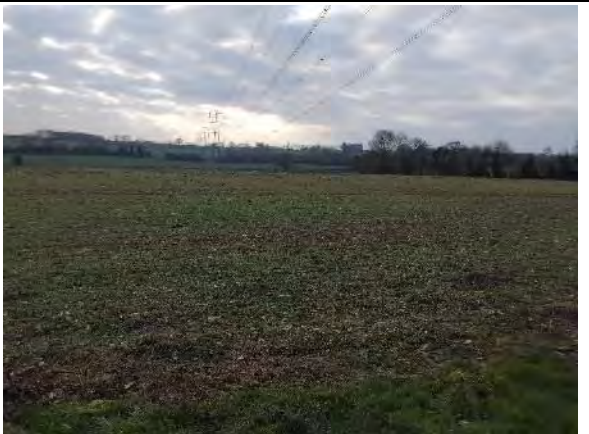
| <p>Photo 5: Image looking southeast through the central part of the southern site area.</p> | <p>Photo 6: Image looking southeast through the central part of the southern site area.</p> |
